Allegheny County Parks Streams Assessment Phase 2 Report Deer Lakes, Round Hill, and Settlers Cabin Parks December 2023 Penn State Extension

Allegheny Watershed Steward Program of Allegheny County

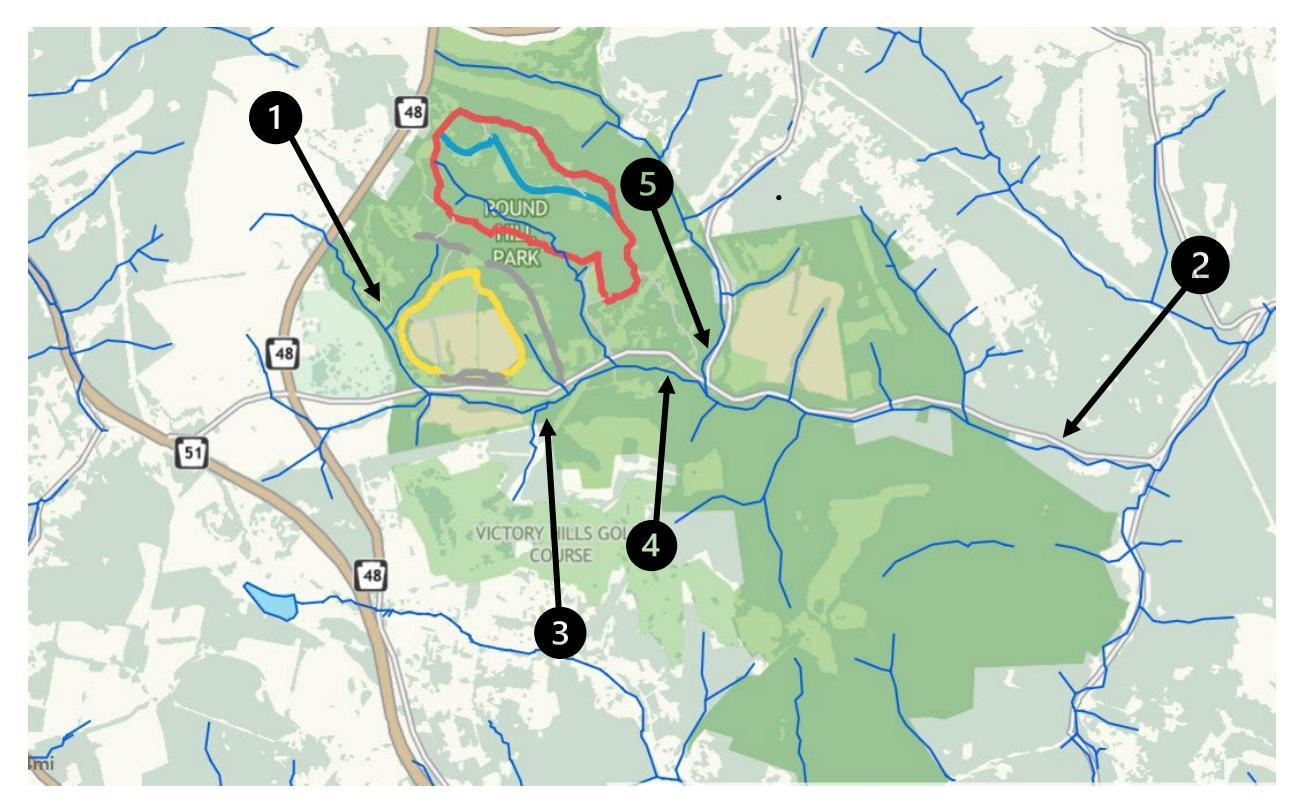
It is estimated that 70 to 80% of the Park's streams are mostly inaccessible by the general public with no nearby parking or trails. As a result, Visual Assessment was targeted at the streams and tributaries that would be most impacted by the recreational and mobility (roads, parking lots, trails) land use areas of the Park. The main stem Douglas Run was also a focus since it's the most downstream receiving water body within the Park.

* just downstream of sampling "site 2", there is a utility right-of-way / forest cut and private road resulting in a lack of riparian buffer. The utility crossing and culvert required for the road crossing are in the reach of the stream that is the most impaired with highly erosive stream banks; the road is collapsing into the stream channel in multiple locations. This location was going to be one of our selected sampling sites however access and conditions proved to be too treacherous.

The visual assessment recorded many debris jams in Douglas Run. Whether due to age or insect damage or other factors, there are a lot of trees that have fallen in the park. While fallen trees across a stream are not inherently problematic in many cases – and often provide valuable habitat - if they are causing erosion because water is trying to circumvent them, selective removal of sections of trees can help to reduce erosion. A review of fallen timber in the park with that in mind is merited.

Restoration of any site with severe erosion at the scale of those along Douglas Run requires an engineering assessment to determine the causes and best restoration technique. Bioengineering could be appropriate but should be applied with a holistic understanding of the source and consequences of the erosion. Bioengineering is likely to be compatible with the management objectives of the park but does require permitting from the Allegheny County Conservation District or Department of Environmental Protection.

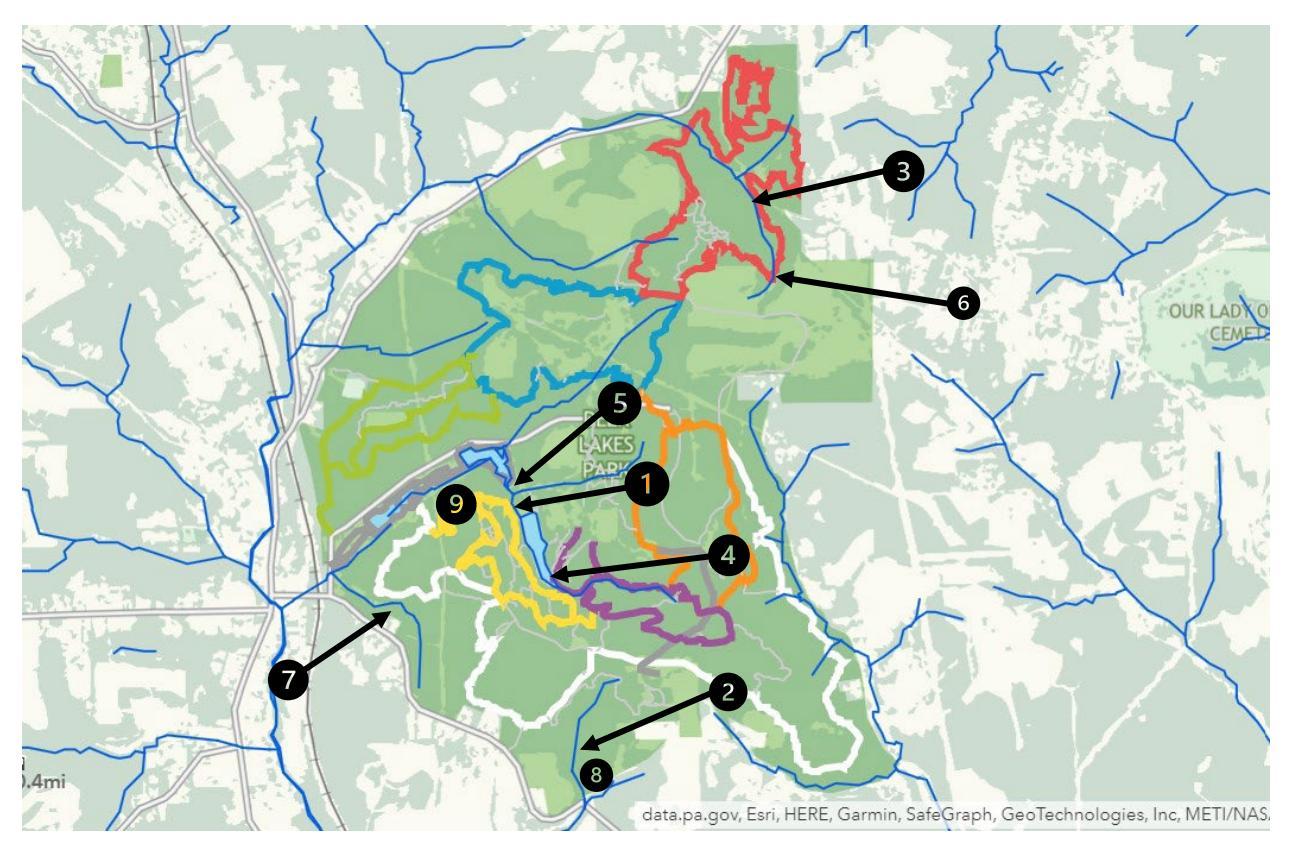
2 Erosion in the stream that flows under Creighton Russelton Road at Russelton Airport Road is 10 feet deep in places.

3 There is a culvert beneath Bakerstown Road that drains into the area near the Red Trail and is eroding the hillside.

9 The access road (grass) above the stream between the lower and middle lake leaves the stream without canopy cover. The hillside between this access road and the stream could use some trees.

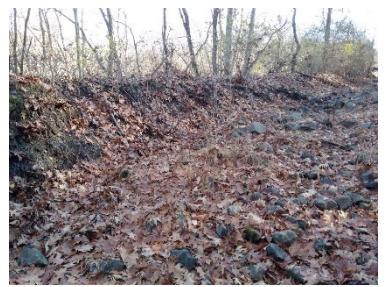
1. The man-made stream channel that flows from the spillway of the upper lake toward the waterfall needs immediate attention. This channel lies between the natural slope of the hillside and a pile of soil. During heavy rain events, the amount of water coursing through this channel is eroding this bank. The soil is loose. This area is prime for live staking to prevent avulsion through the bank as the stream will always seek its original course.

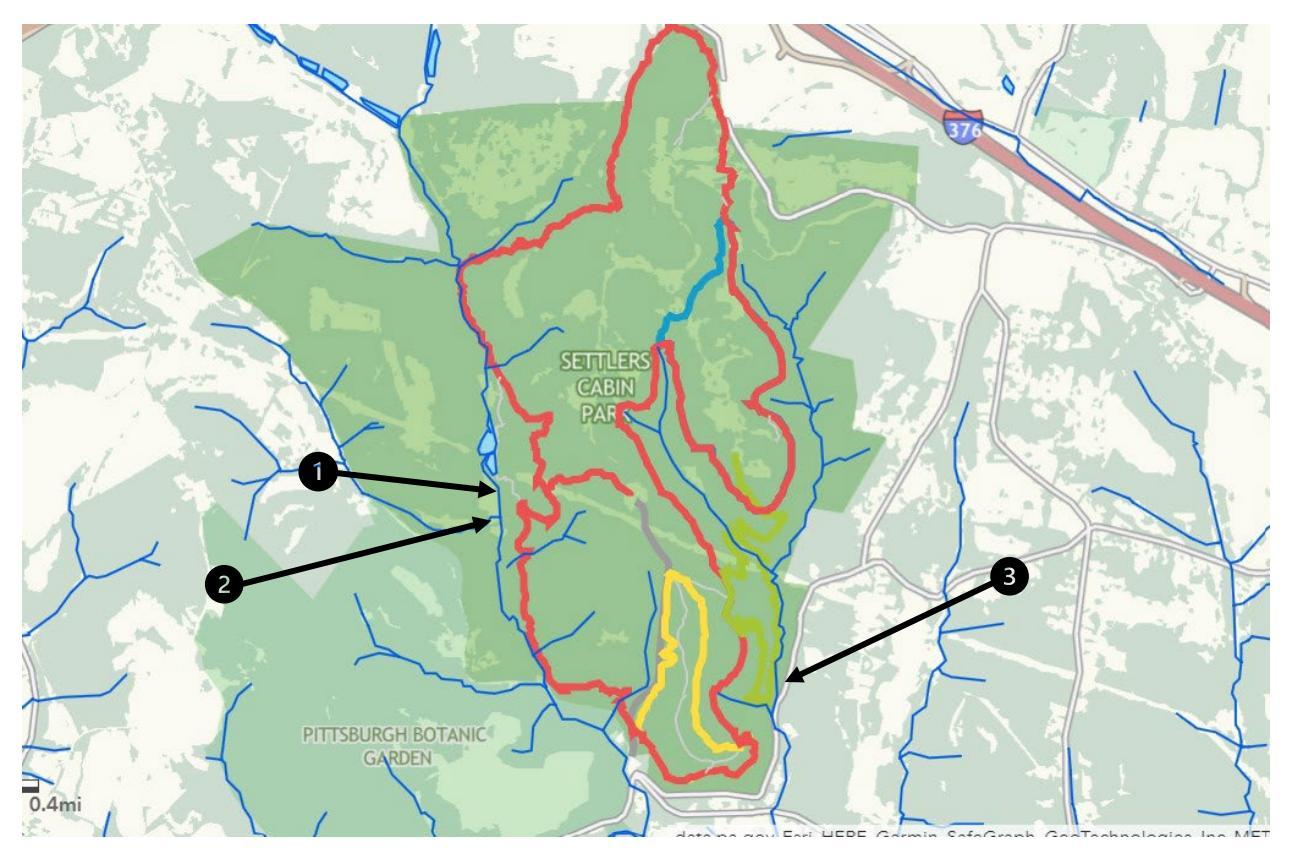
1 Strong gas odor here

2 Milky-white aluminum precipitate (AMD) is obvious in the water at "Site 3". "Aluminum rarely occurs naturally in water at concentrations greater than a few tenths of a milligram per liter; however, higher concentrations can occur as a result of drainage from coal mines, acid precipitation, and breakdown of clays." (Hem, 1970)ⁱ This study did not include sampling for aluminum. Macroinvertebrate sampling did not occur at this site, but did occur downstream of this location at "Site 2" where the macroinvertebrate count scored this reach as only "Fair".

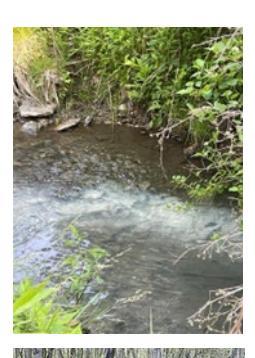
3 Milky-white aluminum precipitate is consistently flowing into collection site "5" from SCST2LT01 tributary. Also, brown/orange AMD consistently emerging from stream embankment creating a small puddle near "Site 5" data collection area.
