ALLEGHENY COUNTY PARKS ECOLOGICAL ASSESSMENT AND ACTION PLAN WHITE OAK PARK

Prepared for the Allegheny County Parks Foundation
December, 2021

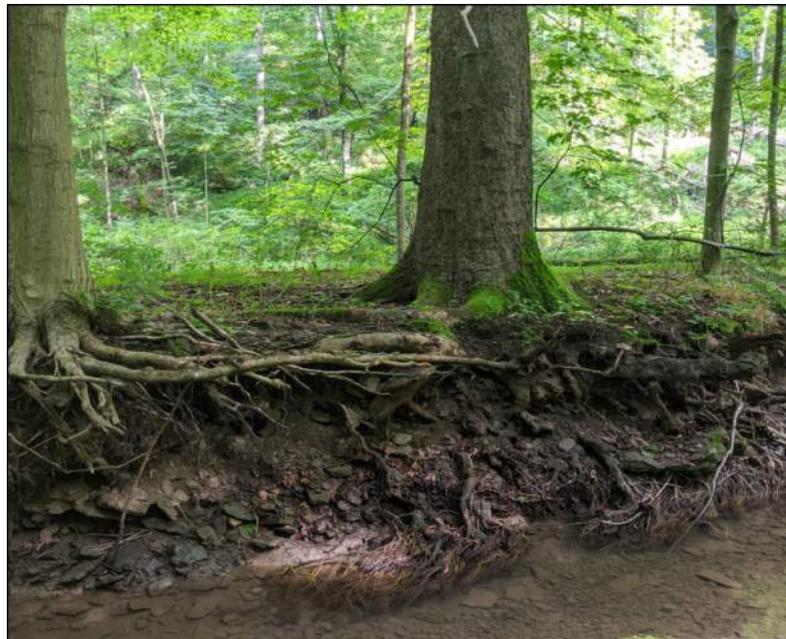
It is most ideal to redress the root causes through improved stormwater runoff management rather than treating only the end result through physical reinforcement where the erosion is occurring. Where streambank erosion occurs within “Best” or “Good” Ecological Integrity areas, physical restructuring should be approached with particular care for the potential of such projects to damage native vegetation, introduce non-native

Streambank Erosion within White Oak Park

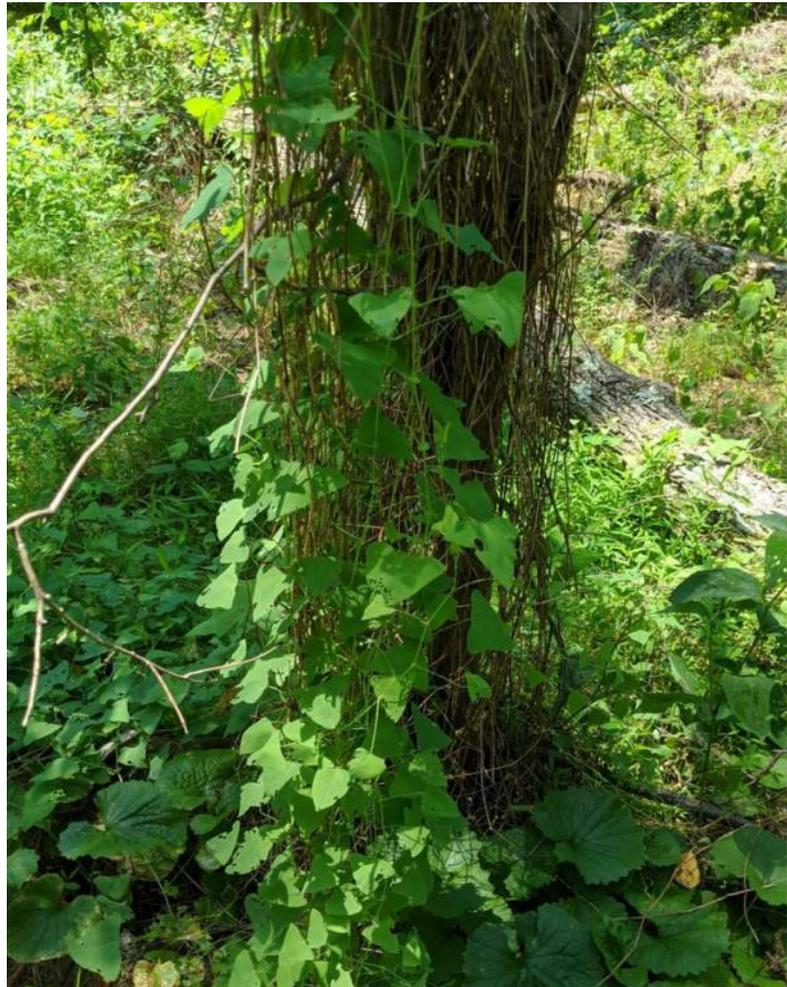
Mile - a - Minute climbing a tree at White Oak Park

- Prioritize removal & reduction of small populations, as this will limit their ability to spread more extensively. Hand-pulling with gloves on is effective and not difficult for a small number of plants. If seeds have not formed, plants can be left to dry; if seeds have already formed, plants must be bagged, removed, and destroyed.

- Prioritize removing or reducing the species where it has established in canopy gaps within “best” ecological integrity areas. In these cases, the best long-term solution is to restore forest in the gap, eliminating the edge and open conditions where mile-a-minute thrives. However, if canopy gap restoration projects are undertaken where mile-a-minute has already established, ongoing control of this species while woody species mature to provide shade must be built into the restoration plan.

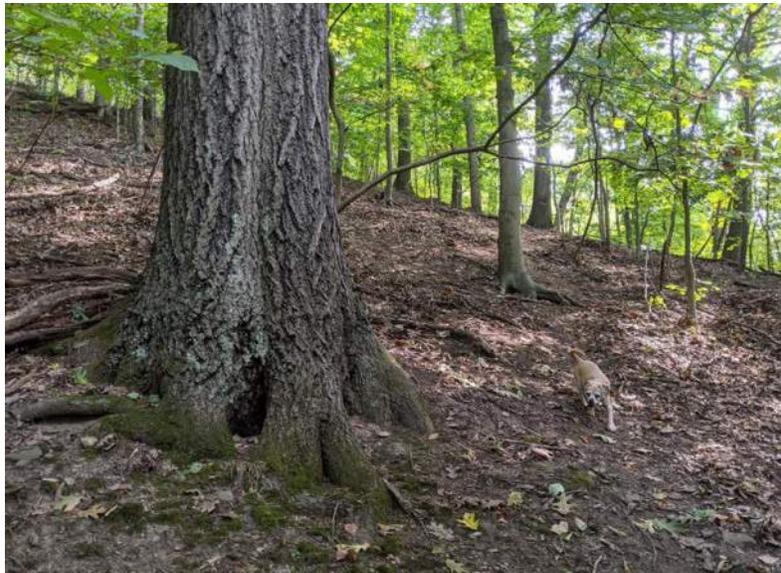
FIGURE 9

- Deer browse pressure makes natural areas more susceptible to the establishment of invasive species by creating bare soil areas and reducing competition from native species. Reducing deer browse pressure can strengthen the natural resilience of forest communities.

Deer Browse within White Oak Park

- Continue efforts to encourage and facilitate deer hunting within the parks and support regional efforts to increase hunting and reduce deer populations.
- Put up deer fencing around any particularly valuable ecological areas that are showing browse impact, and around any restoration projects where new materials are vulnerable to deer browse.
 - At White Oak Park, fencing may be a particularly viable strategy due to the limited areas that still contain good herbaceous diversity, and the location of these areas. See Figure 9.
 - The large areas that currently have low native herbaceous diversity may not recover unless active restoration of native plant material is undertaken, concurrently with protection from browsing.

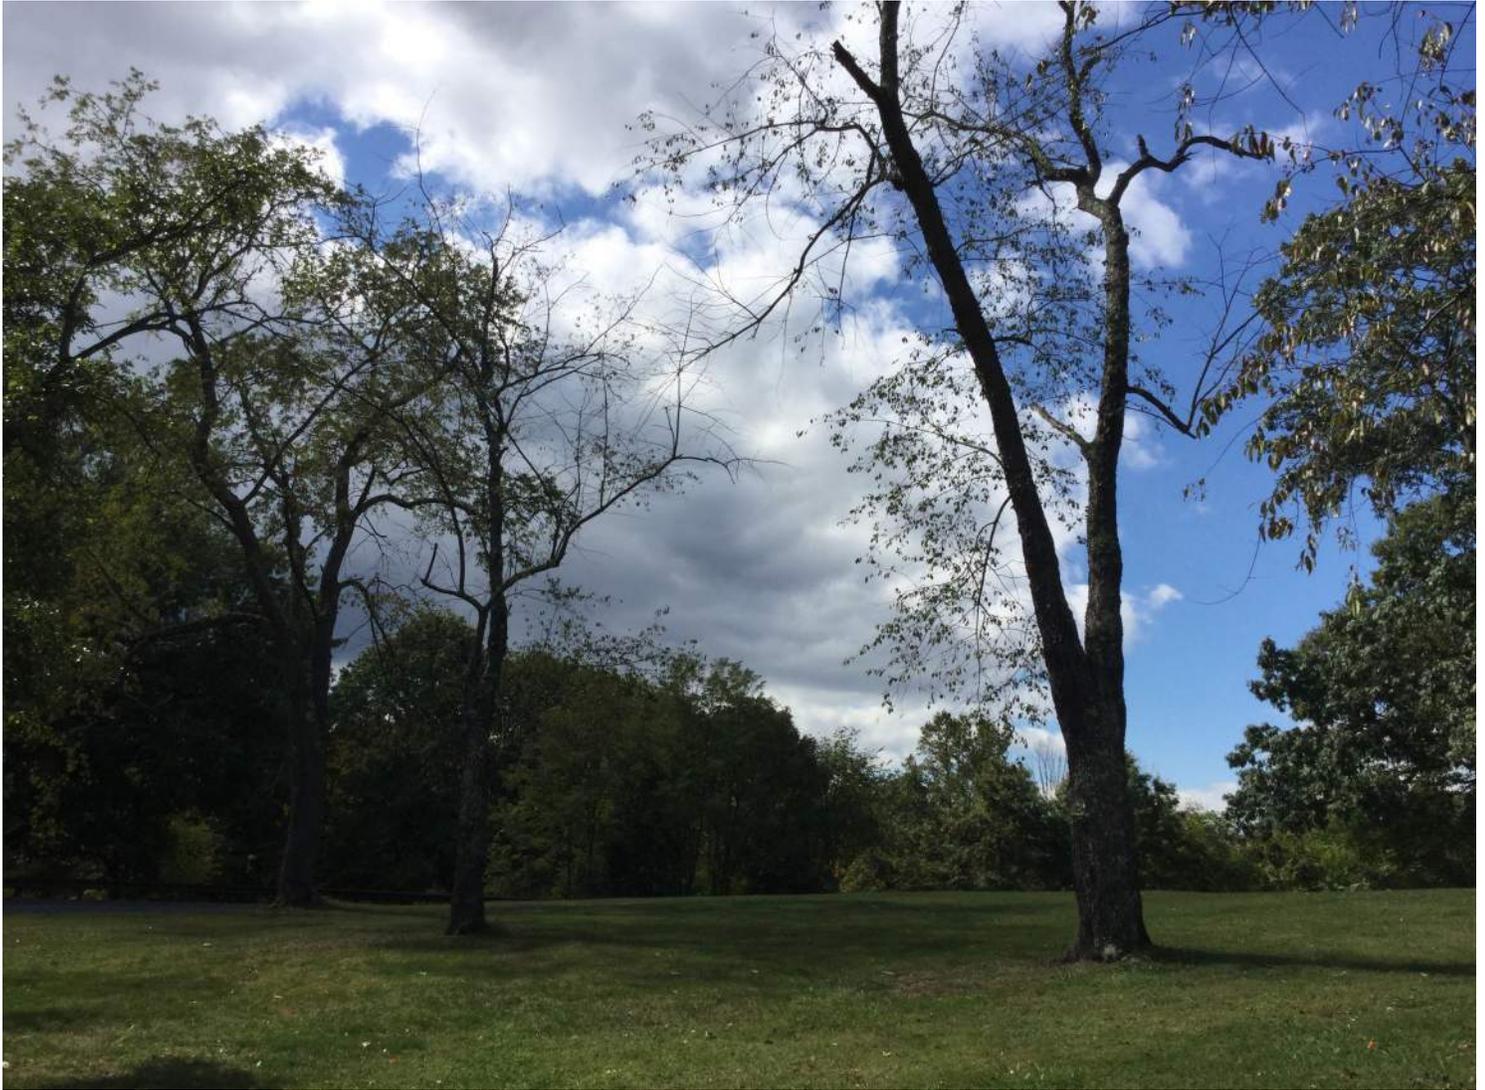
Diseased Black Cherry Trees within White Oak Park

2.1 WHITE OAK PARK: BLACK CHERRY REMOVALS

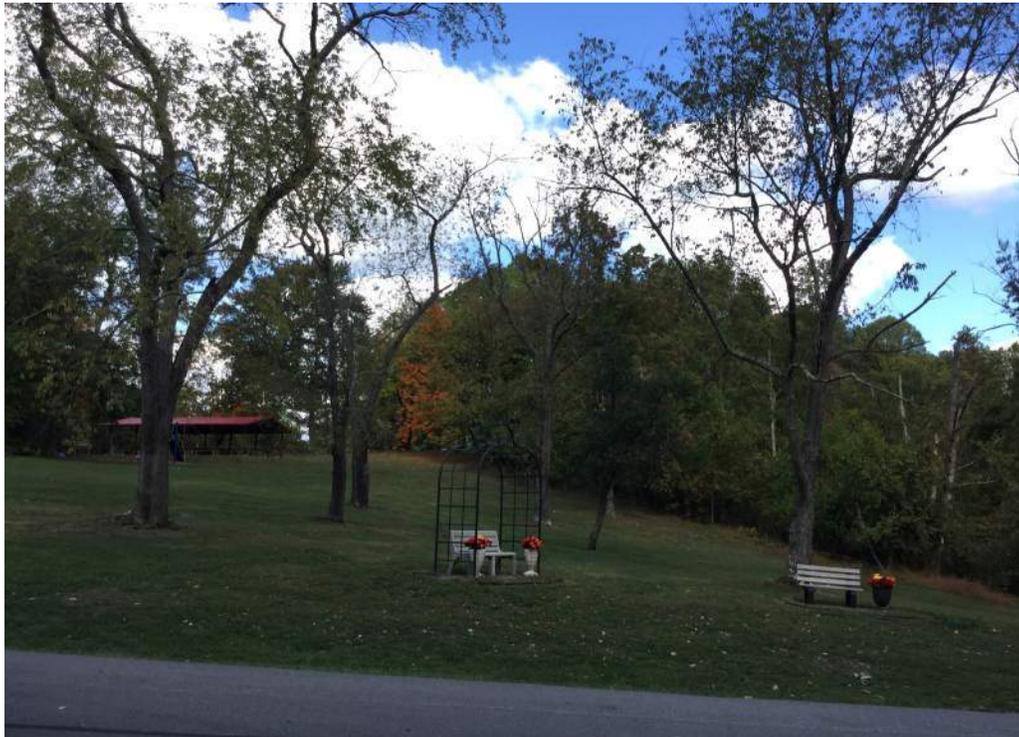
The disease then spreads throughout the tree's vascular system. The tree will respond by plugging up its tissue in an effort to restrict further spread of the disease. In doing so, however, the affected area also becomes cut off from the flow of water and nutrients. This often causes the area to decline. In the case of a canker disease, the progressive growth of the infected area can eventually girdle a branch or stem, further restricting capacity of the tree's vascular system.

Diseased Black Cherry Trees adjacent to the Willow Shelter

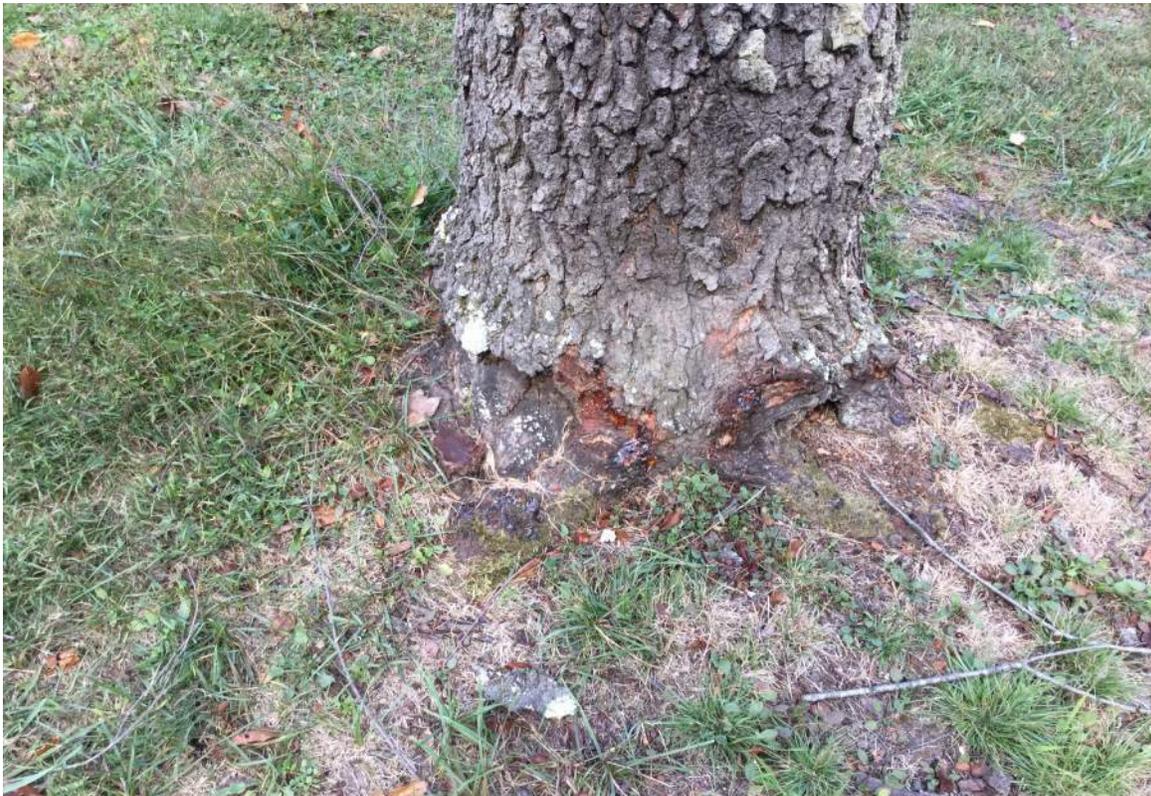
Tree Damage Caused by Mower Deck.

- Mulch all trees, regardless of size, to limit grass and weed growth near tree trunks and major roots.
 - Mulch rings should be maintained annually.
 - Mulch should be only two to four inches deep.
 - Mulch should not make contact with any part of the trunk.
 - Only use undyed, hardwood mulch.
- Raise mower decks and maintain grass at a taller height, at least immediately around a tree.
- Mow less frequently.
- Convert mowed lawns into natural meadows.
- Train park staff to mow/weed trim cautiously around trees.
- Only prune trees in winter.
- Sanitize pruning tools with alcohol after use on each tree.
- Plant trees species in mowed areas that are more tolerant of wounding or root damage (similar to construction sites)

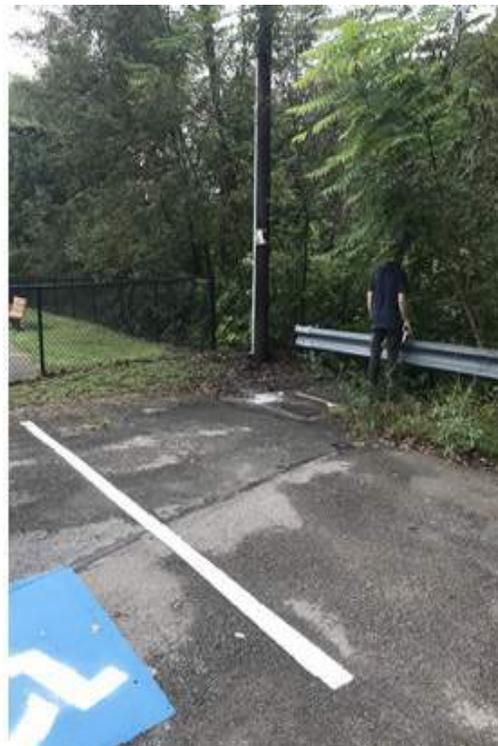
The improvements to the lot do not currently include regrading it to drain to the adjacent green swale that exists to the northeast of the lot. Regrading could be prohibitively expensive but there is the possibility of positioning the new solar panels (covering about half of parking lot) to help redirect at least some of the runoff from the panels to the swale next to the parking lot. Currently, the parking lot runoff travels to the southwest corner of the parking lot where it enters a catch basin and then a pipe that discharges the runoff about 10 feet above the grade of the stream.

Parking Lot Catch Basin

Trenches installed within the parking lot to redirect the water to the northeast swale are not advisable due to a high level of maintenance.

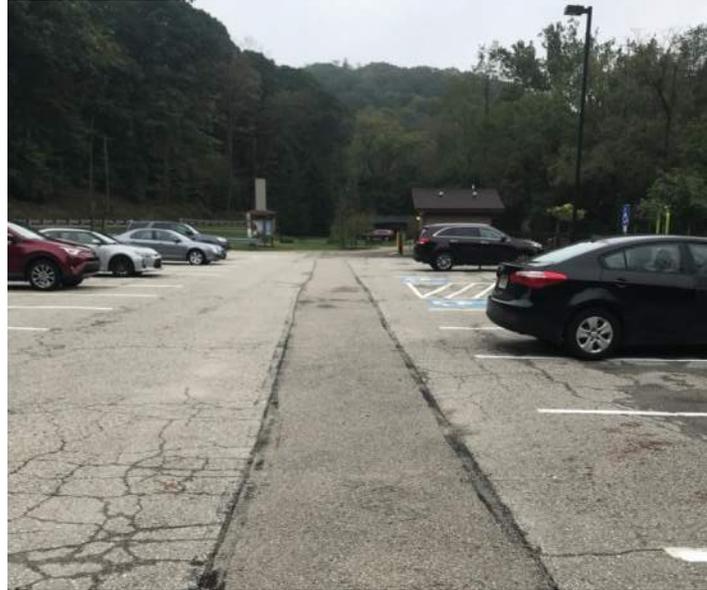
Chestnut Grove Parking Lot, slated for 2022 upgrades.

Another possible intervention would be removing some of the existing asphalt in the southwest portion of the lot and installing a bioswale where plants and rocks can capture, polish, and slow the runoff before it enters the catch basin and is discharged into the stream.

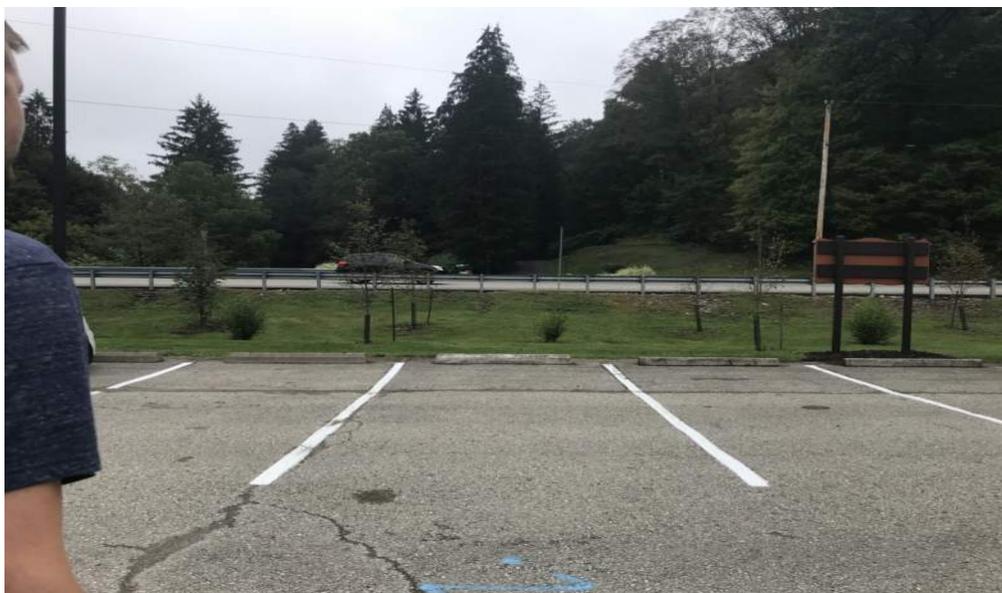
Greenspace adjacent to the Chestnut Grove Parking Lot. Stormwater does not currently enter this greenspace..

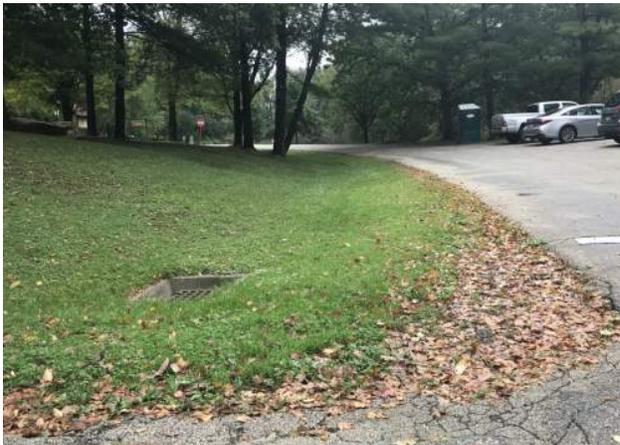
At the Wedding Gardens site, runoff from White Oak Park Ext. (road) and the parking area is captured in a series of catch basins that lead to a stone culvert and then ultimately discharge to a large lawn area. Erosion is evident in this area, as it is in other similar situations throughout the park.

Wedding / Gardens Mountain Ash Area

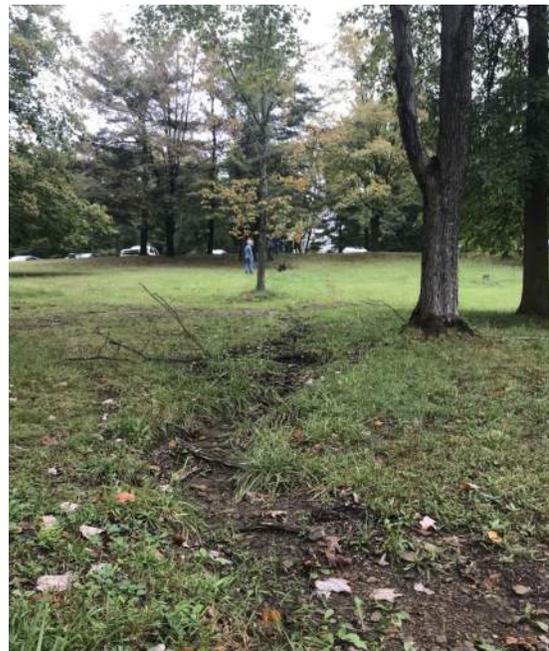
Erosion from Runoff off the Parking Area

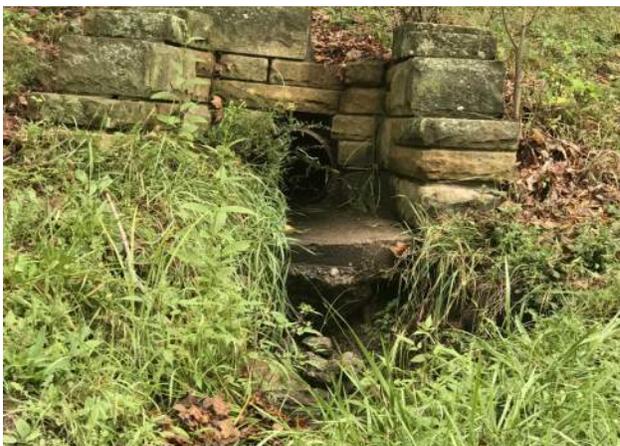
Stone Culvert

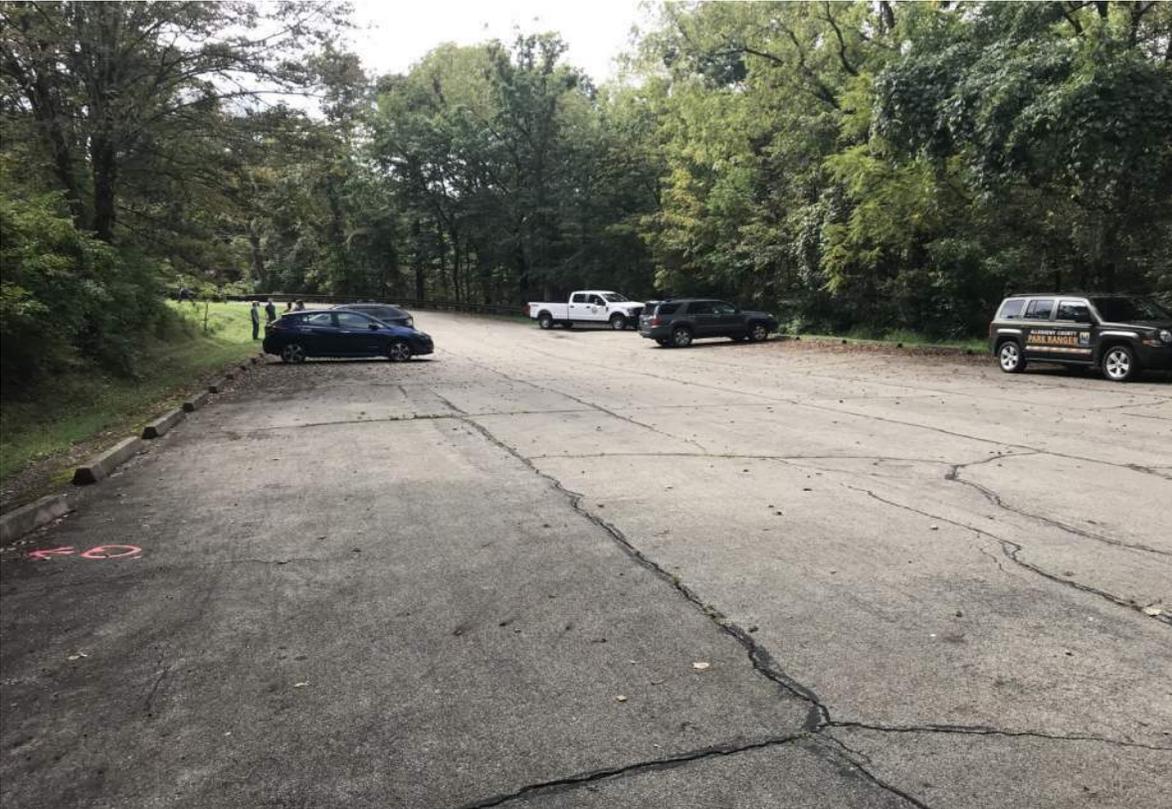
Cedar One Shelter Parking Lot

The catch basins within and around the “Cedar One” shelter parking lot capture a significant amount of stormwater runoff from other nearby parking areas and White Oak Park Exd Road, causing severe runoff, erosion, and sedimentation in the adjacent woods and unnamed stream. This may be a location where subsurface retention facilities would be effective. Otherwise, retention would be required further up the sewershed to slow runoff and reduce non-point source pollution and sedimentation in the stream.

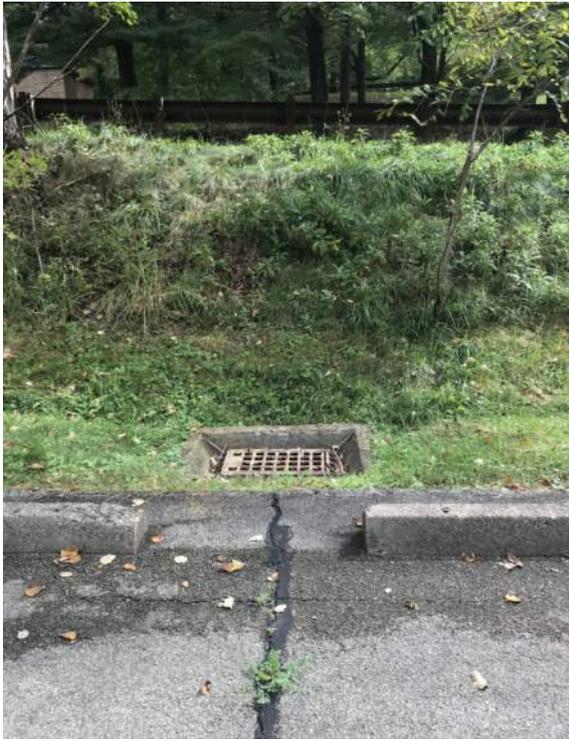
Catch Basin next to the Cedar Grove Lot.

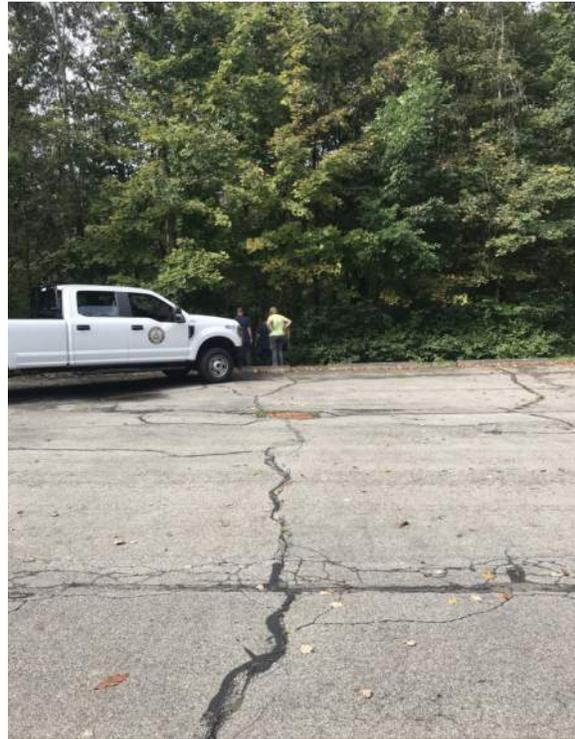
Catch Basin in the Center of Cedar Grove Lot, just above the Outfall Pipe

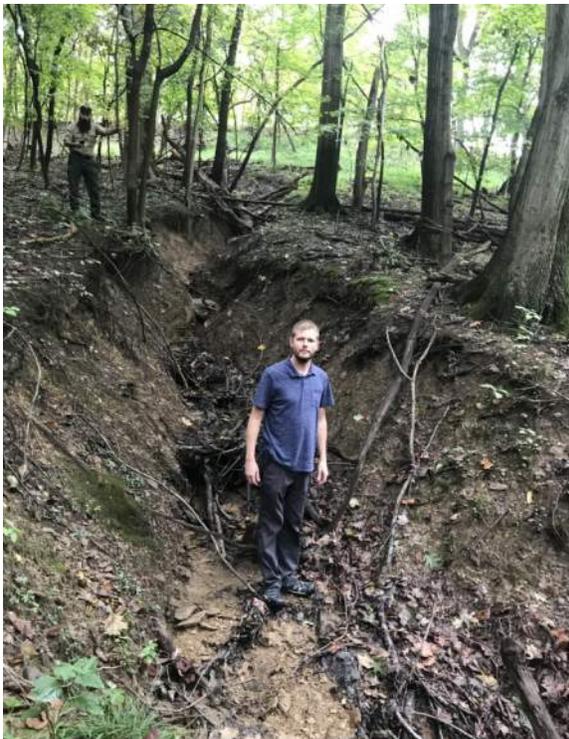
Severe Erosion Affecting Stream Morphology & Habitat.

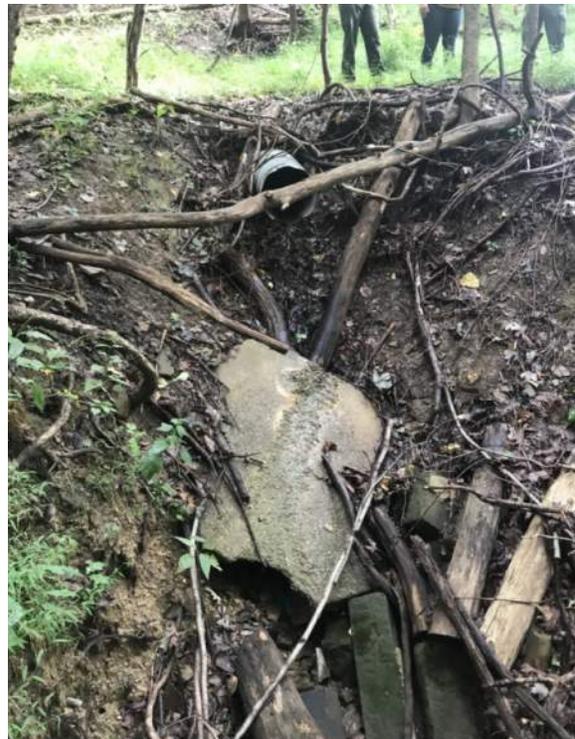
Severe Erosion from the Outfall Pipe from the Cedar Grove Lot

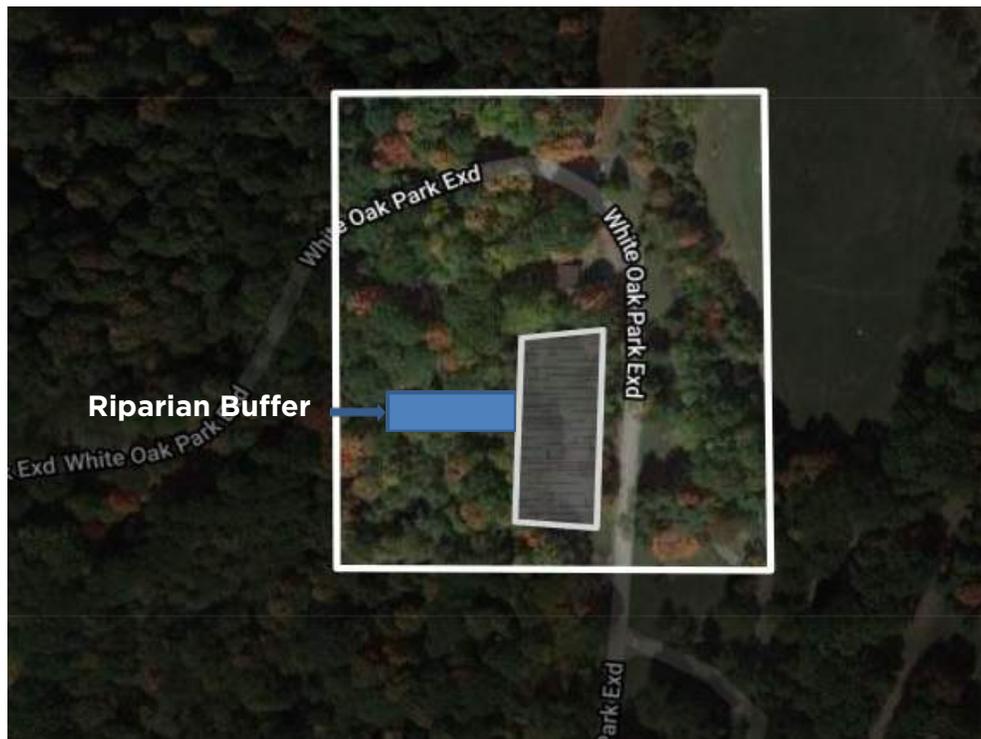
Proposed Retention Tanks & Riparian Buffer Plantings for Cedar Grove Lot

- Hydrologic analysis to determine runoff volume and size of retention tanks.
- Infiltration Testing
- Land Survey
- Riparian buffer design and planting plan.
- Demolition of existing asphalt parking lot.
- Construction—excavation, tank installation, sewer/catch basin connections, stone weir installations.
- Volunteer planting and maintenance events.
- Monitoring and maintenance.
- Informational signage.
