# Allegheny County Parks Streams Assessment Phase 1 Report

Hartwood Acres, Harrison Hills,  
and White Oak Parks

December 2022

Penn State Extension  
Allegheny Watershed Steward  
Program of Allegheny County

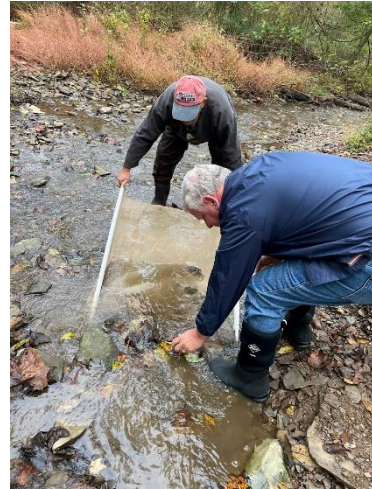
Macroinvertebrate surveys were conducted using a 1mX1m kick net which is anchored in the bottom of the stream. A 1-meter square area of substrate immediately upstream of the net is "kicked" (disturbed) for a set length of time to flush animals into the net. Sampling is done in different types of habitats to identify animals with different feeding and habitat preferences. Animals captured were scored using the "Hoosier Riverwatch Biological Monitoring" score sheet which weighs each taxonomic order present based on their sensitivity to pollution and generates a Pollution Tolerance Index (correlated to water quality) of "poor", "fair", "good", or "excellent". The scoring system applied does not address individual counts for each taxonomic Order but provides an appropriate level of assessment for this study.

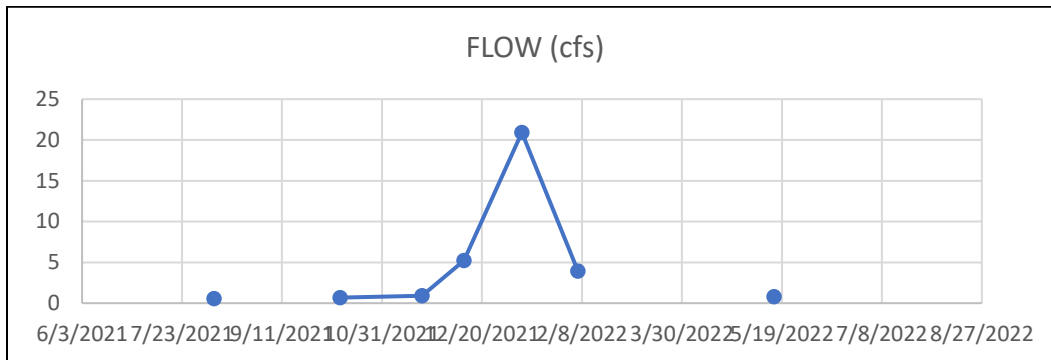
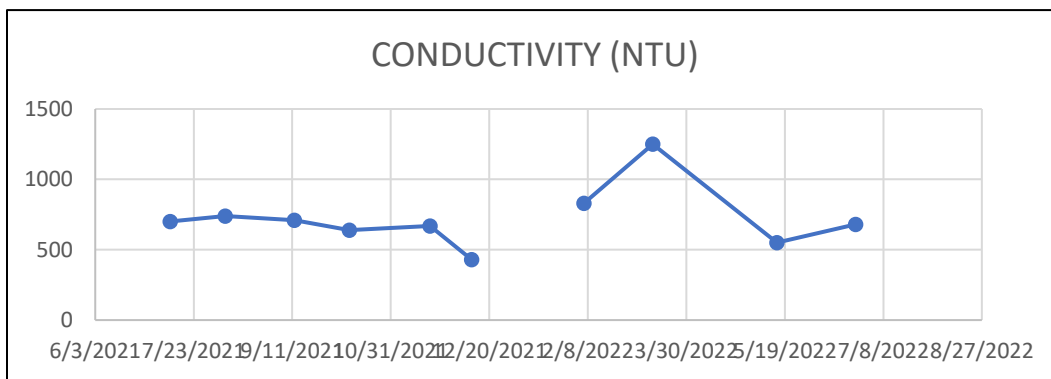
Flow, Turbidity and Conductivity at White Oak Park

Looking at the chemical conditions in a stream tells only part of the story. With strong DO values in place fairly consistently, we know that at least one condition is met for sustaining healthy biological communities. Looking at the condition of the physical environment helps to provide additional information for the full story. And as noted earlier, the type of biological community present is a result of the physical and chemical conditions combined.

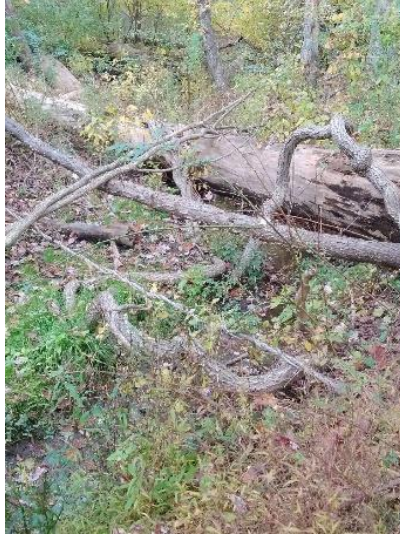
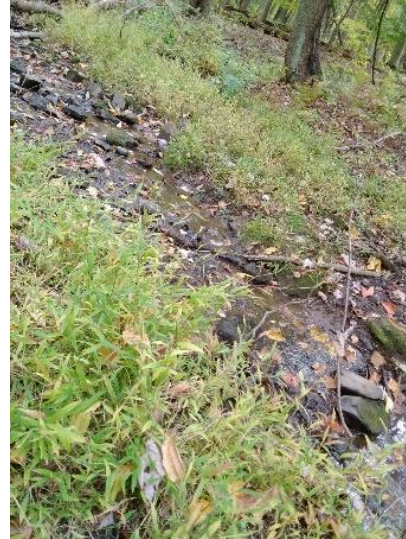
- 1) The northern boundary of the park along near the fence has had some canopy reduced by invasive vines pulling trees down (see photos to right) and insect damage. This has left the area open to invasive species colonization and stream degradation. A planting of species like those cited by the Conservancy in this area, as well as forest canopy restoration would promote infiltration and reduce erosion and siltation in the stream downstream.

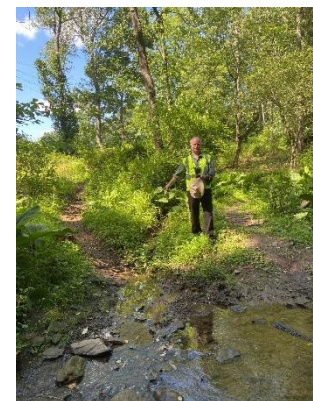
3) Horse and pedestrian traffic cross Little Pine Creek at the confluence of the trail from Green Valley Drive, creating significant sediment as they traverse the stream or its borders. (See photo at right.) Because equestrians use that trail, any attempt to prevent disturbance of the streambed would need to have a non-slip texture. A geo-textile secured across the stream - as farmers do for cattle - would address that concern in a cost-effective way. A wood-decked bridge over Little Pine Creek would be a more expensive solution but might be more aligned with the aesthetic goals of the park.

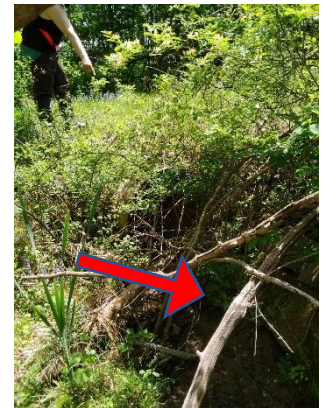
1) The history of part of the park's land as a dumping ground for various materials has left a legacy of debris that makes access to at least one stream channel hazardous and might be causing erosion. The stream valley directly east of the parking lot for the ball fields contains both glass which had been dumped there historically as well as slag and extensive fallen timber, possibly due to slag contamination of the soil. The photo (right) shows a hidden area of erosion in that area. As a legacy situation, any attempt to remediate the area would be expensive and could prove counterproductive by disturbing unconsolidated materials that are at least partially covered by vegetation. The historical pattern of using swales or valleys as dumping grounds should end. Asphalt millings, tree debris, or any other materials placed in

or near a swale - regardless of how shallow - can contribute to erosion and downstream impacts during storm events when water uses those otherwise dry depressions.

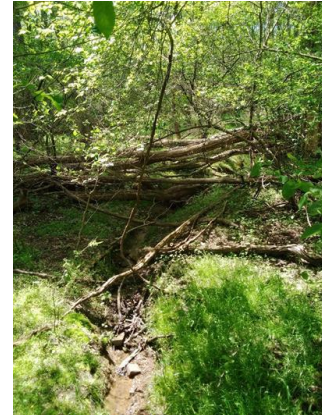
2) Whether due to age or insect damage or other factors, there are a lot of trees that have fallen in the park. While fallen trees across a stream are not inherently problematic in many cases - and often provide valuable habitat - if they are causing erosion because water is trying to circumvent them, selective removal of sections of trees can help to reduce erosion. A review of fallen timber in the park with that in mind is merited.

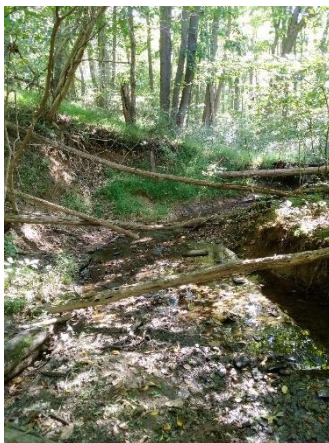
3) A section of Rachel Carson Run between Cottontail Drive and the Purple Trail has severe erosion and should be targeted for investigation into the causes of the erosion. Until then, recommendations for remediation are premature.

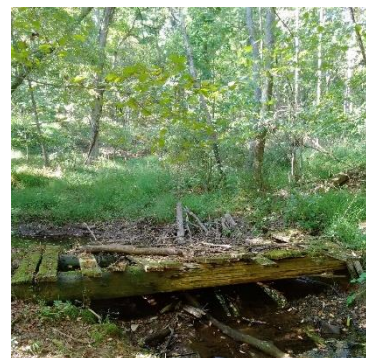
4) Several old bridges are resting in stream channels and can be promoting the accumulation of debris that prevents free flow of water along the channel or diverting the flow and causing erosion. Each of the structures should be studied and removed in a manner that enhances the channel's stability and function.

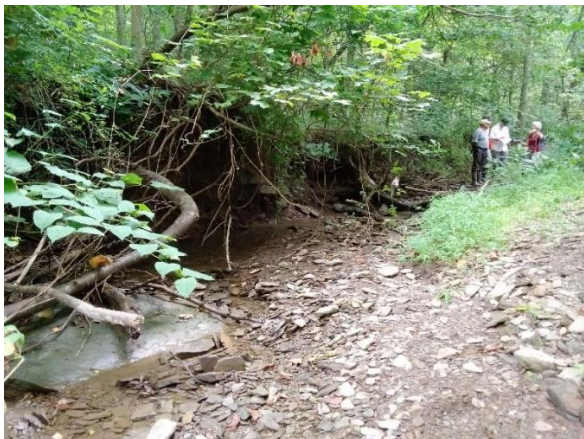
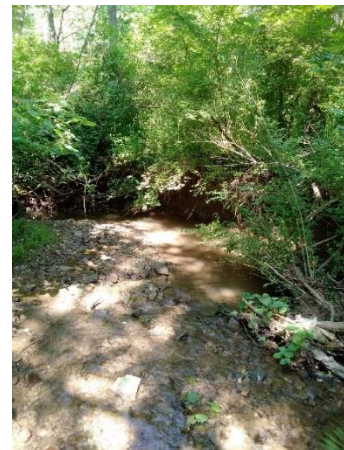
1) Of the three parks studied in Year 1, White Oak Park has the most mowed area at the top of the terrain the park occupies. Between the mowed areas and roadways, considerable surface flow and culverted stormwater is directed to the streams, resulting in extensive erosion. This is especially evident along the main stream downstream of the culvert under McClintock Road uphill from the playground which receives water from two streams traveling down steep gradients. (See photo to right and two at top of next page.)

Restoration of any site with severe erosion at the scale of those above requires an engineering assessment to determine the causes and best restoration technique.

Bioengineering could be appropriate but should be applied with a holistic understanding of the source and consequences of the erosion.

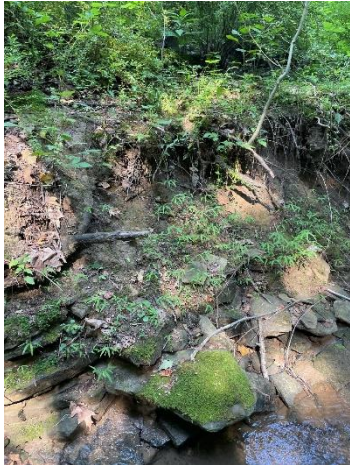
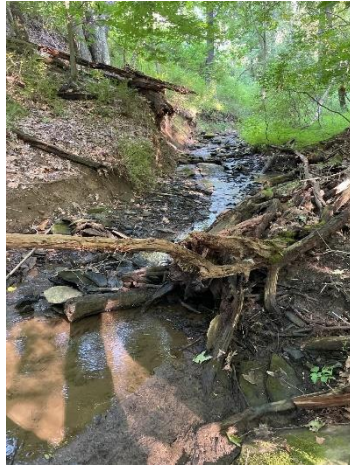
2) Similar scouring is seen at the base of the stream along the purple trail near where it meets the tributary running parallel to Stewartsville Hollow Road (photos below.) Live stake plantings in eroded slopes like these might slow erosion but are inadequate in strong scouring environments.

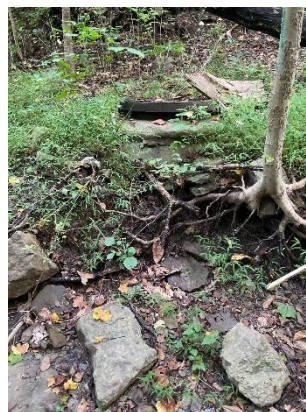
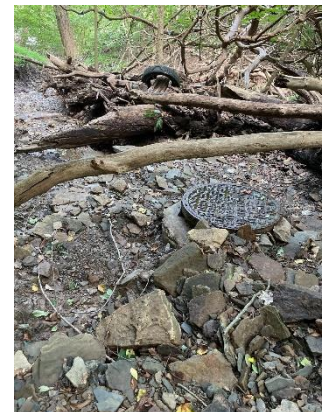
3) Lastly, the historical practice of installing sewer lines down stream valleys is visible at White Oak Park. The manholes below are in the valley behind White Oak animal shelter. The construction of sewer lines in valleys destabilizes the channel material with this kind of erosion and makes debris accumulation nearly inevitable. A review of the debris and options for judicious removal and planting of small shrubs that will not disrupt the sewer could be explored.
