Allegheny County Parks Streams Assessment Phase 3 Report

North, South, and Boyce Parks

December 2024

Allegheny Watershed Steward
Program of Allegheny County

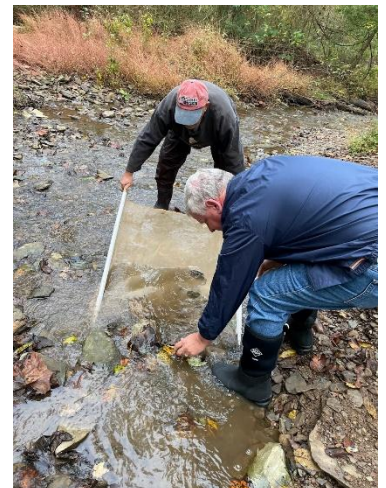
Macroinvertebrate surveys were conducted using a 1mX1m kick net which is anchored in the bottom of the stream. A 1- meter square area of substrate immediately upstream of the net is "kicked" (disturbed) for a set length of time to flush animals into the net. Sampling is done in different types of habitats to identify animals with different feeding and habitat preferences. Animals captured were scored using the "Hoosier Riverwatch Biological Monitoring" score sheet which weighs each taxonomic order present based on their sensitivity to pollution and generates a Pollution Tolerance Index (correlated to water quality) of "poor", "fair", "good", or "excellent". The scoring system applied does not address individual counts for each taxonomic Order but provides an appropriate level of assessment for this study.

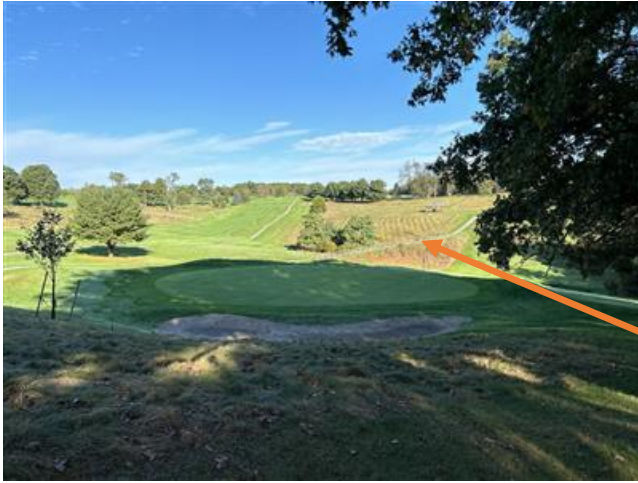
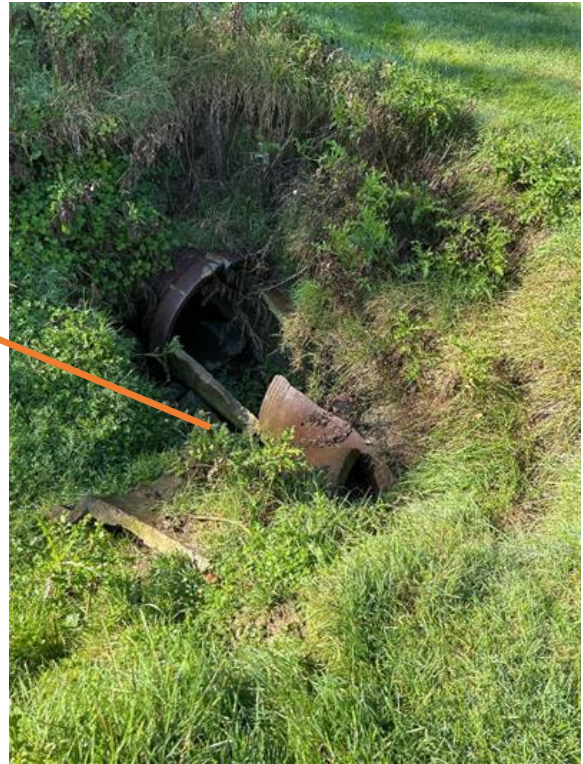
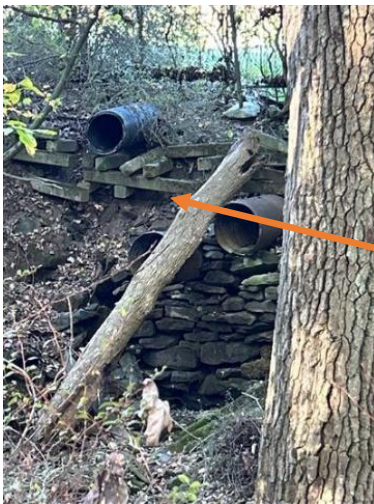
1. North North Park Golf Course has a large clay drainage pipe beneath the area pictured below. This pipe has collapsed and created several cavities. This may pose a safety risk to course users. These cavities are not marked. Rain that falls on this area of the course drains rapidly to the low spot and finds its way into that broken pipe. Layout of golf course: <https://www.golfpass.com/travel-advisor/courses/11414-north-park-golf-course#layout> The pipe outfall exits the golf course through wood cribbing that is rotted and failing. This needs attention. The height of the outfall of this drainage pipe may be contributing to the deep erosion of the stream to which it is plumbed. See the photo where the assessor is using the trekking poles to show the

steepness of the channel here. The course photo included here shows the amount of land area that is draining to this one spot. See photos included here.

Wood cribbing is failing

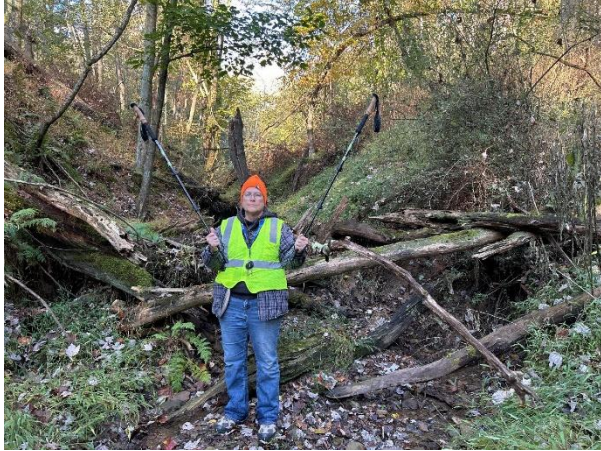
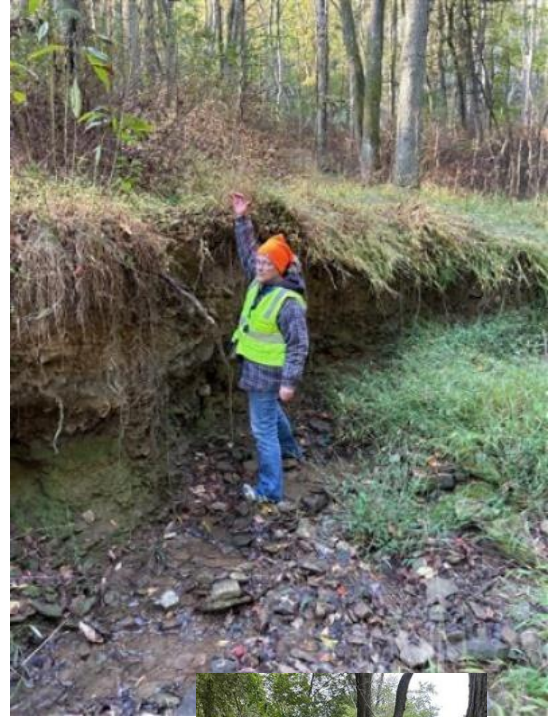
Note angle of poles in assessor's hands indicating slope of adjacent hillsides and depth of erosion in this same channel.

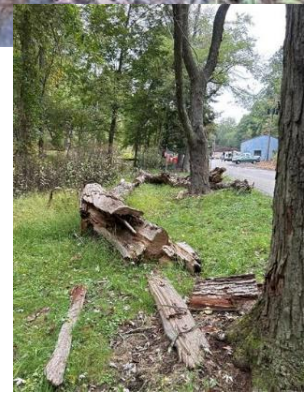
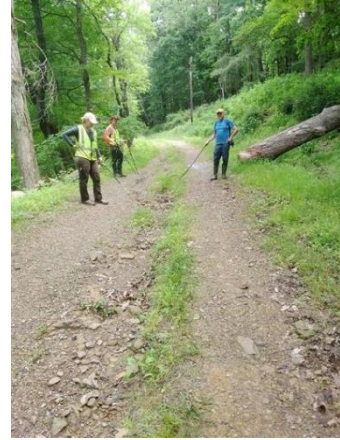
2. Many concerns exist at the maintenance facility along McKinney Road. *Materials piles should be isolated in such a way to prevent runoff during heavy rains. *All bare soil should be seeded or have silt socks below them. *Just below the gate, there is evidence that the runoff from the access road is strong and is eroding the streambank. This area could be left to grow up to provide a natural barrier for debris and litter to be trapped before it reaches the stream. *There is a significant amount of litter on the facility grounds

that will be carried to the stream via the storm drains. Routine litter cleanup is advised. *There are piles of used or reclaimed construction materials and debris piled along the stream. Any substance or fibers from these piles make their way

into the stream. *The site's dumpster has a platform so that users can reach the opening but there are large amounts of trash lying around the dumpster and between the platform and the dumpster. As this entire area is paved, all of this debris will wash down the driveway and end up in the stream. *There is a large storage tank (presumably for a petroleum product) near the entrance gate with a concrete containment pad beneath but there is an open drain hole that will not prevent spillage from leaving this containment area. (see the photo at left showing open hole) *The log segments pictured above will actually help the situation by slowing the flow of runoff and preventing mowers from mowing here. *This vehicle washing station's water is collected in a storm drain and plumbed to the creek. *Trash like this exists in multiple places on this property.

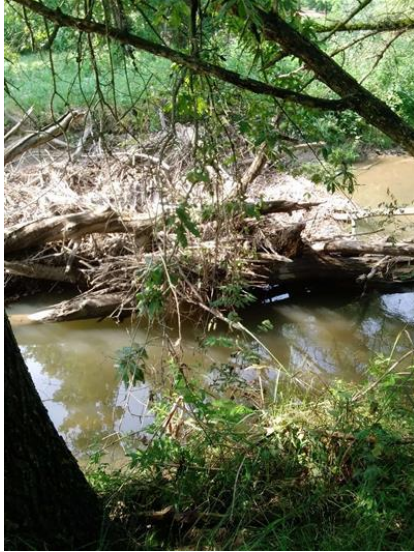
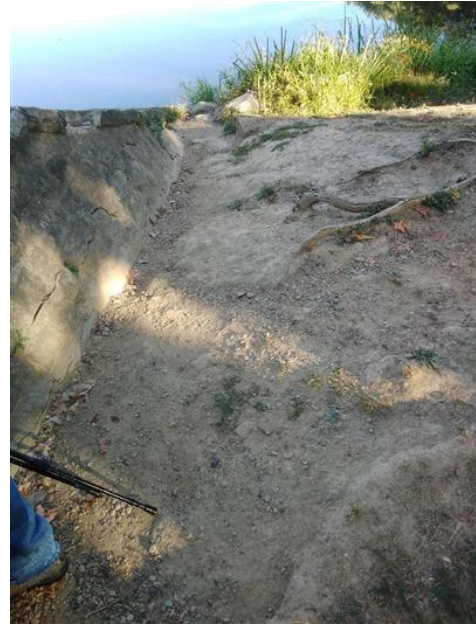
7. There is a massive debris jam in Pine Creek that should be removed because high flows are circumventing the jam and eroding the banks around it. The jam is also impeding drainage of a pipe outlet.

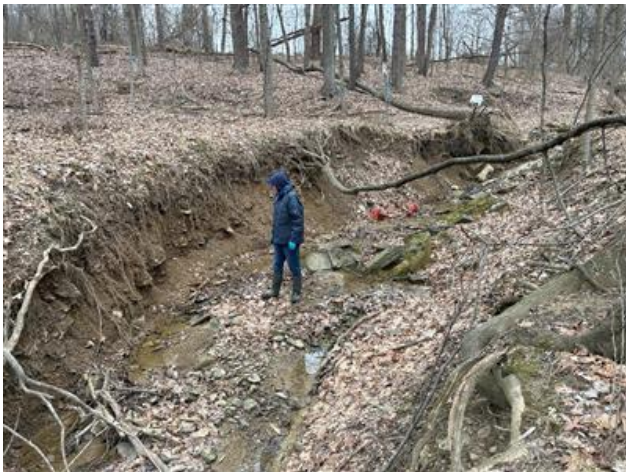
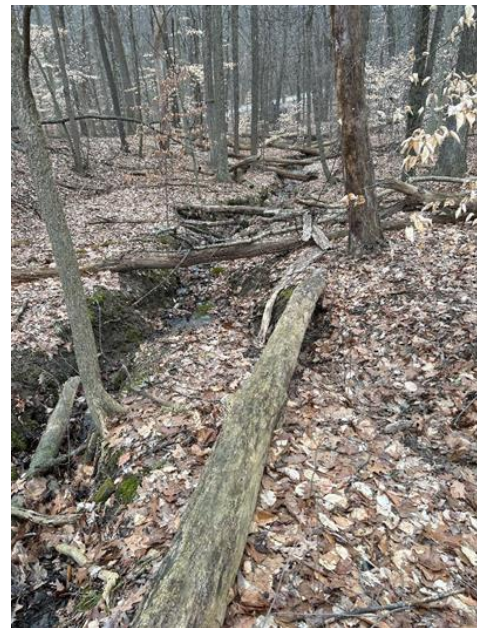
7. South Park Golf Course runoff is causing significant erosion of the stream that drains this area. *The course surface itself is eroding near holes 7 and 8. Golf course layout: <https://www.golfpass.com/travel-advisor/courses/11761-eighteen-hole-at-south-park-golf-course#layout>. *There are natural springs causing turf slippage along hole 11. The water leaving the course along hole 11 is causing deeply scoured ruts in the hillside through the woods pictured here. *On the day of assessment, we found mud pits on the course near the tee box of hole 10 that swallowed our boots halfway to our knees.

*There are small groves of trees in the valley between holes 7 and 10. These are not located in a fairway, yet evidence of mowing tall absorbent plants exists. This area need not be mowed. *The culvert that drains the course into the woods is exposed and soil over it has eroded away. A walk along the stream through the woods reveals severe erosion caused by high flows from the golf course. For scale, the man pictured here is 6 feet 2 inches tall. The damage here is severe. Most of the stream that drains the golf course here is deeply scoured with vertical banks. Near the bottom of the woods, next to what appears to be private property, there is a culvert that is plugged and water is circumventing the culvert. Here, the stream has reclaimed its natural watercourse and is draining into its floodplain.

On the golf course(s) specifically, installation of *vegetated swales* across the face of sloped fairways or between holes will greatly reduce runoff that accumulates in the valleys. In addition to infiltrating stormwater to assist in groundwater recharge, these swales filter pesticides and fertilizers. South Park's 1927 course design includes vertical, paved cart paths that serve as runoff highways as is evidenced by the trails of tree seeds, mulch, twigs, and leaves left on the paths after rain. Rerouting these paths is not feasible, but converting cart paths and parking lots to permeable paving will reduce runoff. Maintenance personnel will be able to identify areas that are frequently wet and waterlogged and troublesome to maintain. These areas could benefit from installation of rain gardens to slow water runoff and naturally filter water pollutants for which golf courses are famous. Detention ponds or retention ponds are an option for the area of collection where holes 7 and 10 meet. A fountain to aerate the water can prevent eutrophication and the water could be recycled for course irrigation. Allegheny County Parks golf courses could be a model for green infrastructure and sustainability.
