Allegheny County Parks Streams Assessment Phase 2 Report Deer Lakes, Round Hill, and Settlers Cabin Parks December 2023 Penn State Extension

Allegheny Watershed Steward Program of Allegheny County

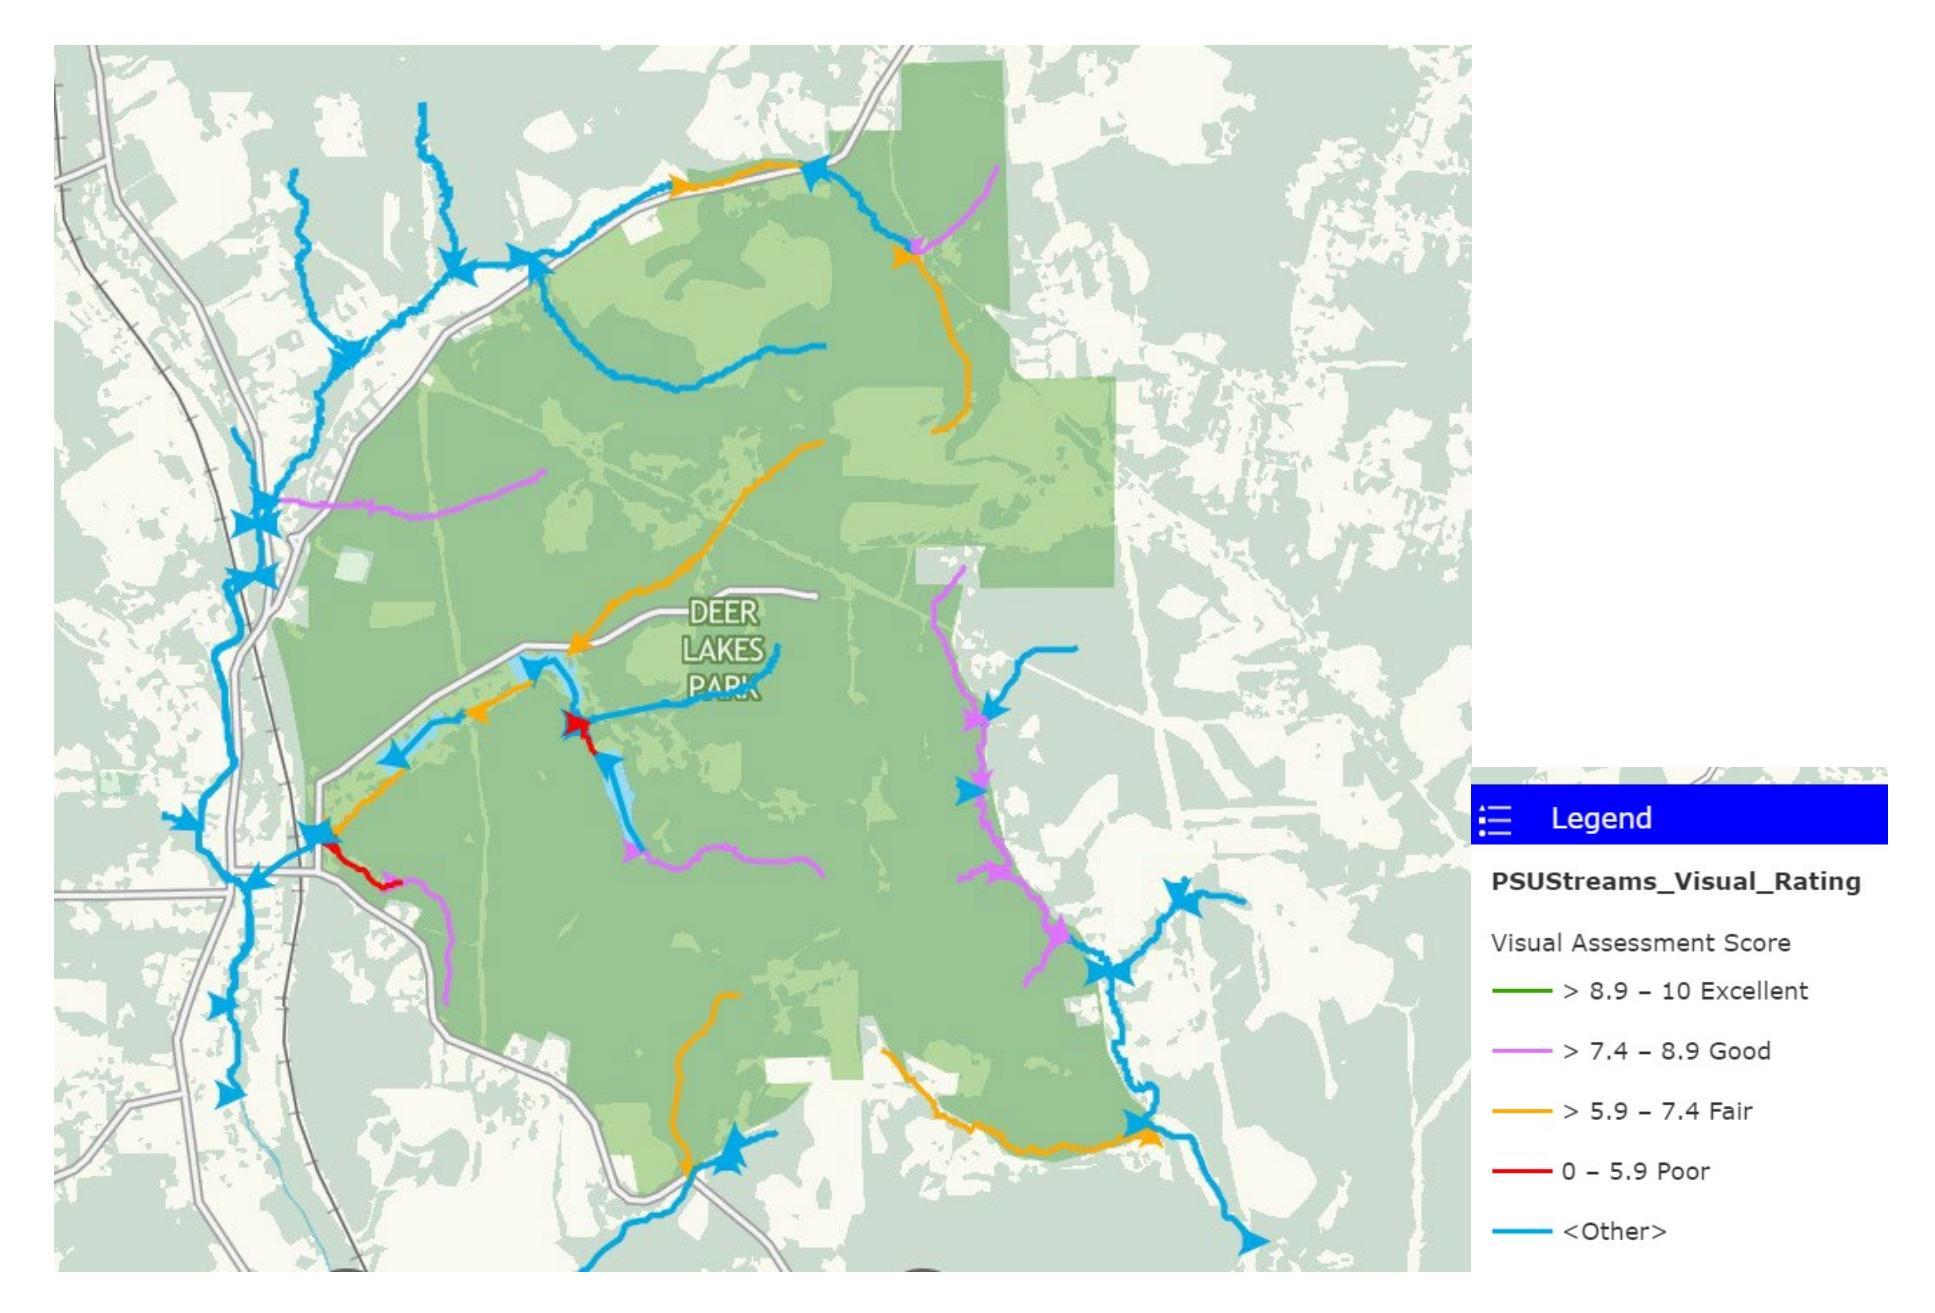
Deer Lakes Park - STREAM RATINGS MAP

Deer Lakes park received an "Excellent" score for one site, and "Good" and "Fair" for the other two sites.

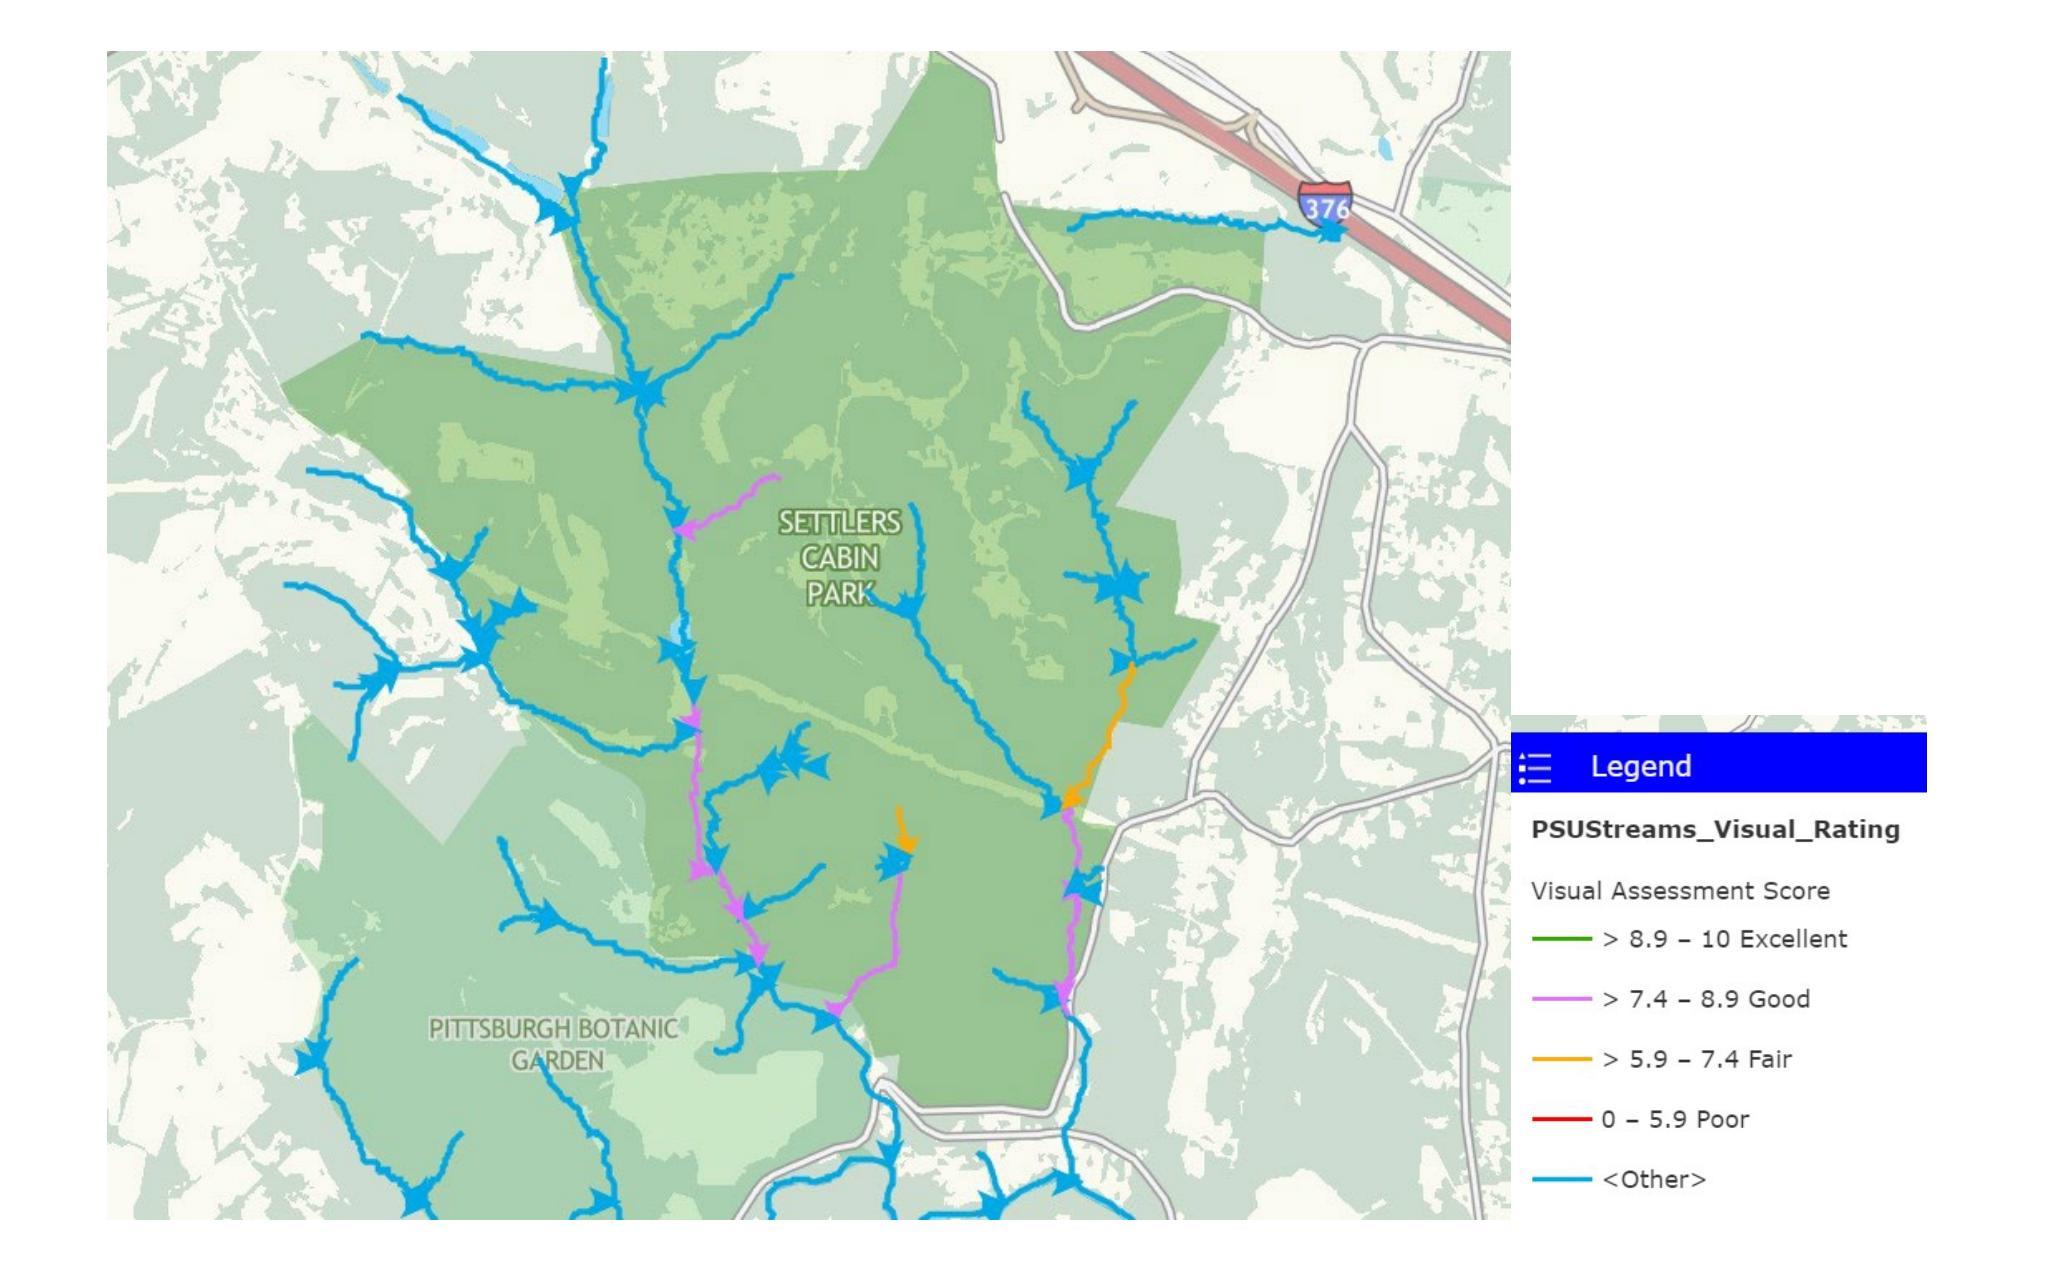
Settlers Cabin Park - STREAM RATINGS MAP

Settlers Cabin Park received one "Good", one "Fair", and one "Excellent" score.
