ALLEGHENY COUNTY PARKS ECOLOGICAL ASSESSMENT AND ACTION PLAN HARRISON HILLS PARK

Prepared for the Allegheny County Parks Foundation
February, 2023

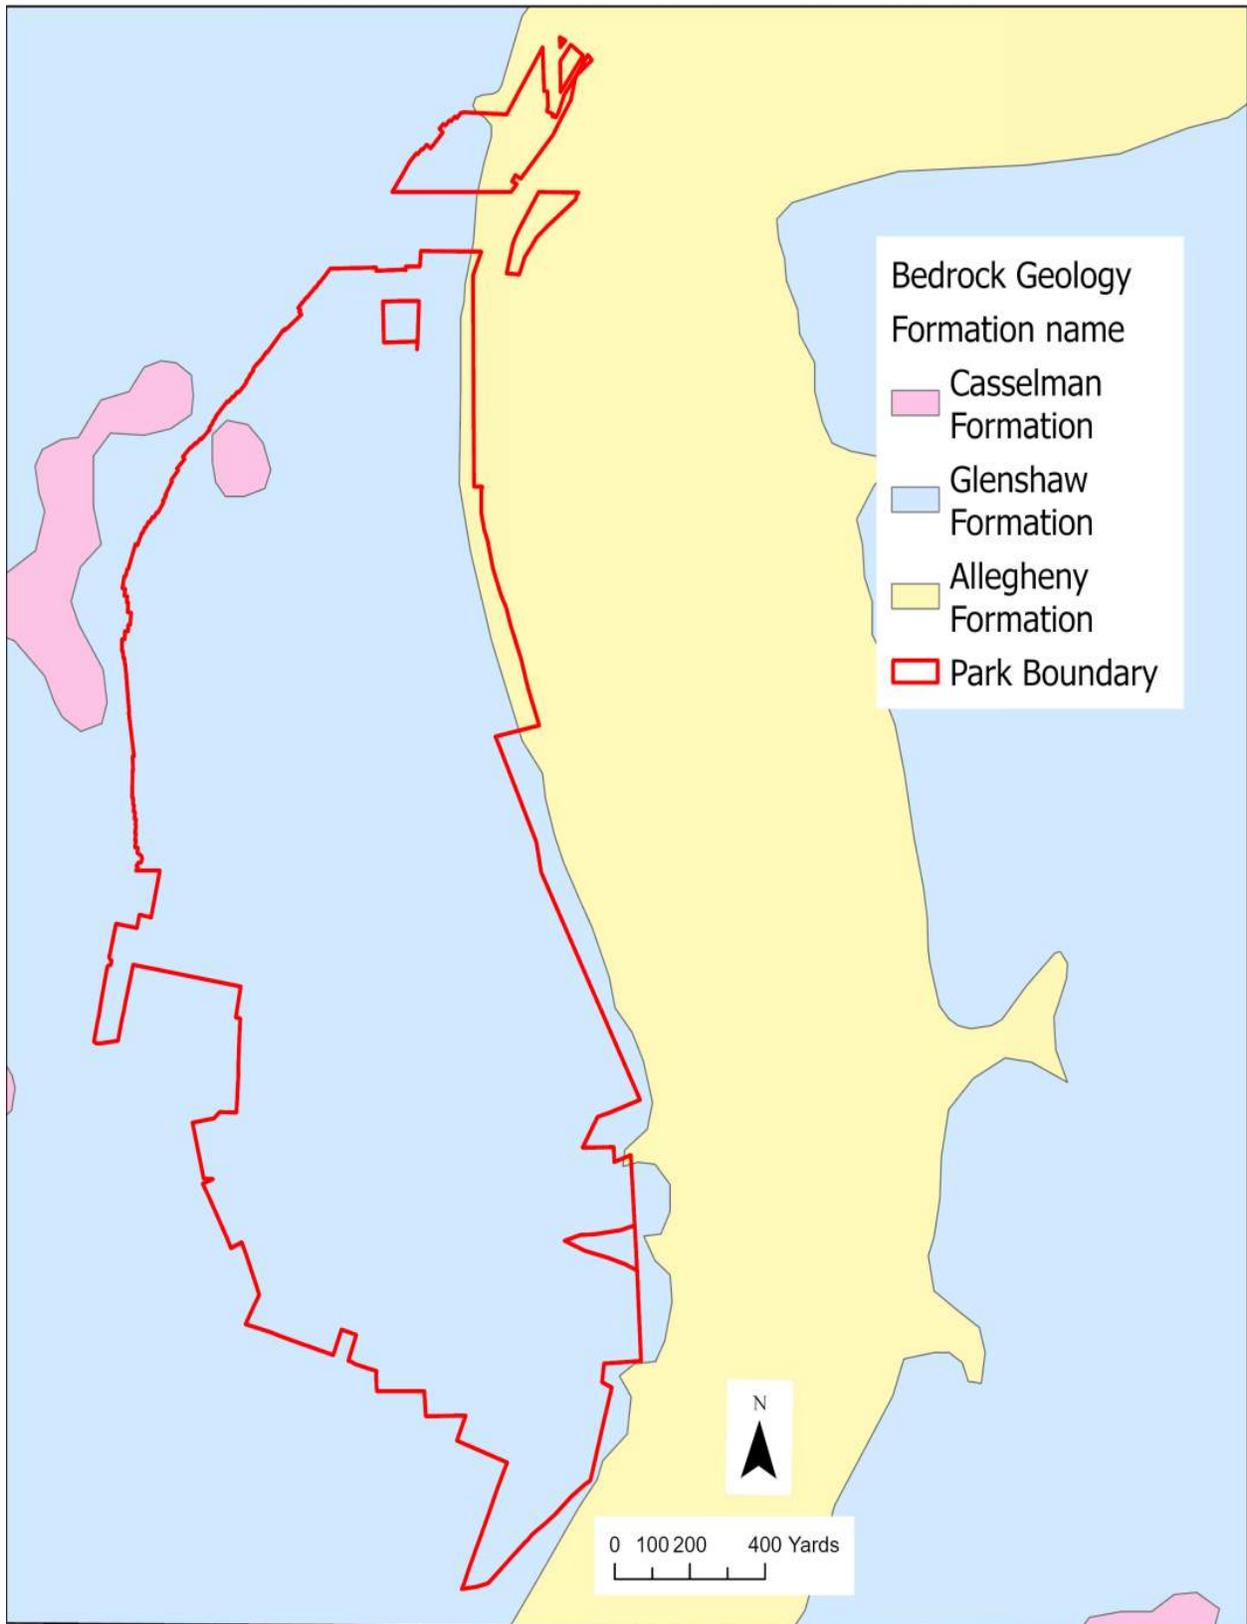
Harrison Hills Park Surface Geology

The Glenshaw and Casselman formations consist of layers of shale, siltstone, sandstone, red beds, thin impure limestone, and thin nonpersistent coal. They contain very little calcareous material, except for a limestone layer called the Ames limestone, which occurs at the boundary of the two formations. This 2-4' thick layer can form small outcroppings, and is notably rich in marine fossils. Where the Ames limestone is exposed on slopes by erosion that has cut through the geological layers, it may create a local zone roughly 5' to 10' in width that is enriched by calcareous materials. Besides this layer, the overwhelming character of the surface geology is acidic and mineral-poor.

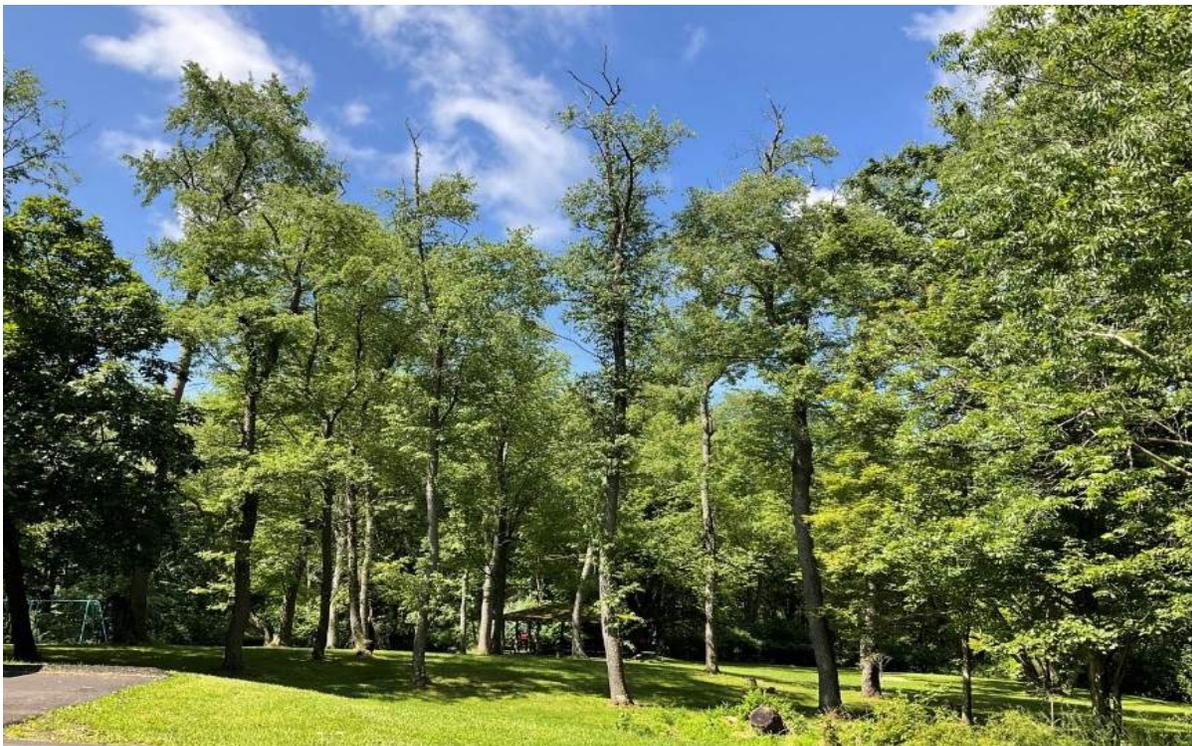
While disease and fungal decay are occurring within the trees currently, the initial cause of this tree decline is a prolonged history of mower damage to the lower trunk and root system. The repeated removal of outer tree tissue and the creation of exposed wounds result in consistent pathways for tree pests and diseases to infest the tree. Furthermore, the blades of the mowers can transport disease from one tree to another. The stress of from weakened root systems and disease can then compound with heat, drought, or storm damage to cause tree failure.

Trees presenting hazards along Sportsman Park Drive

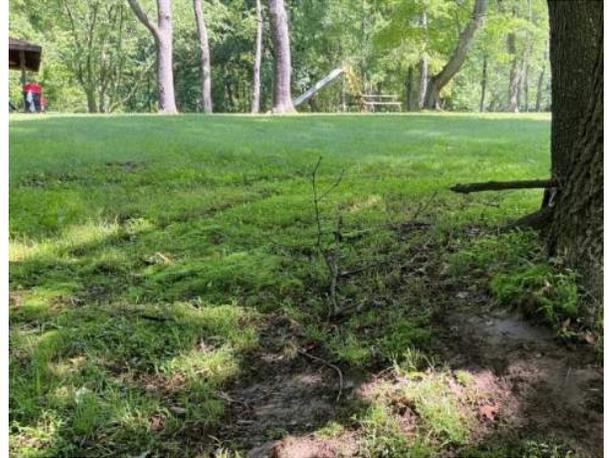
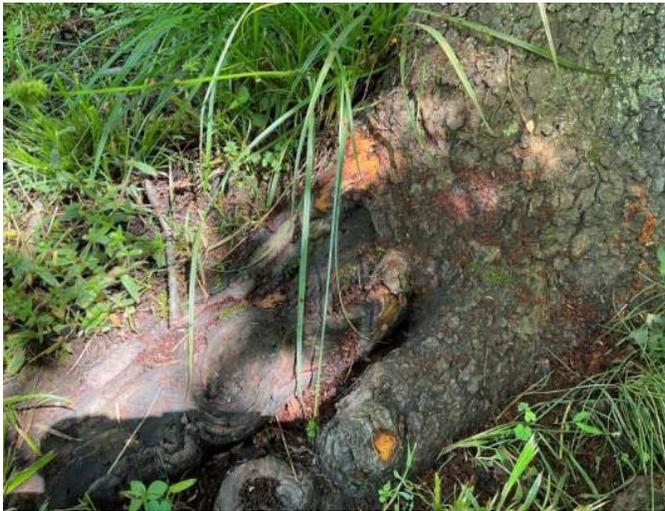
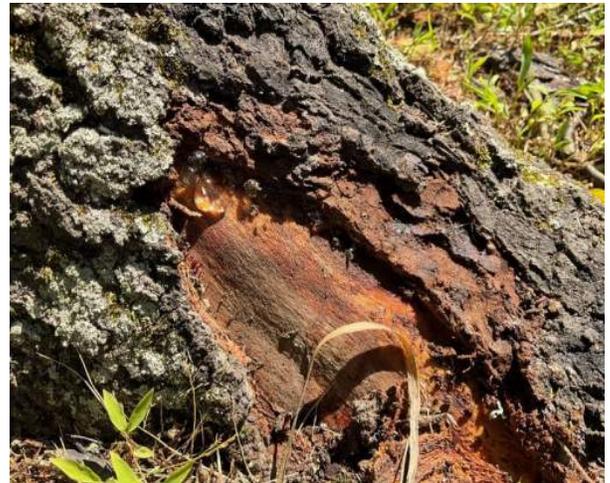
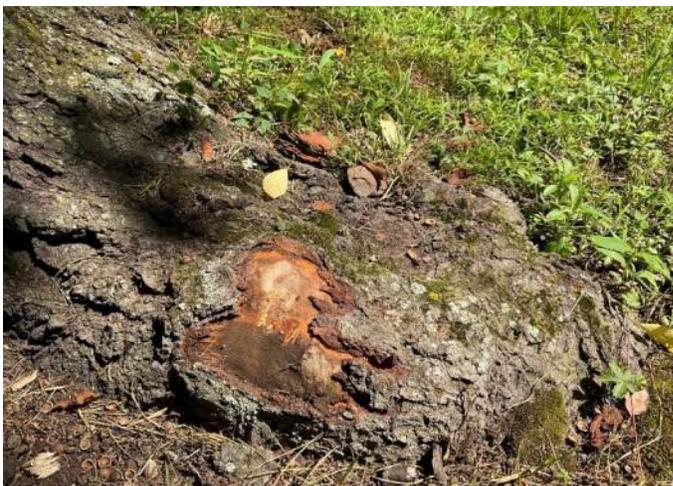
The following photos highlight the described damage to tree roots from lawnmowers at the Sportsman Park Drive Shelters.

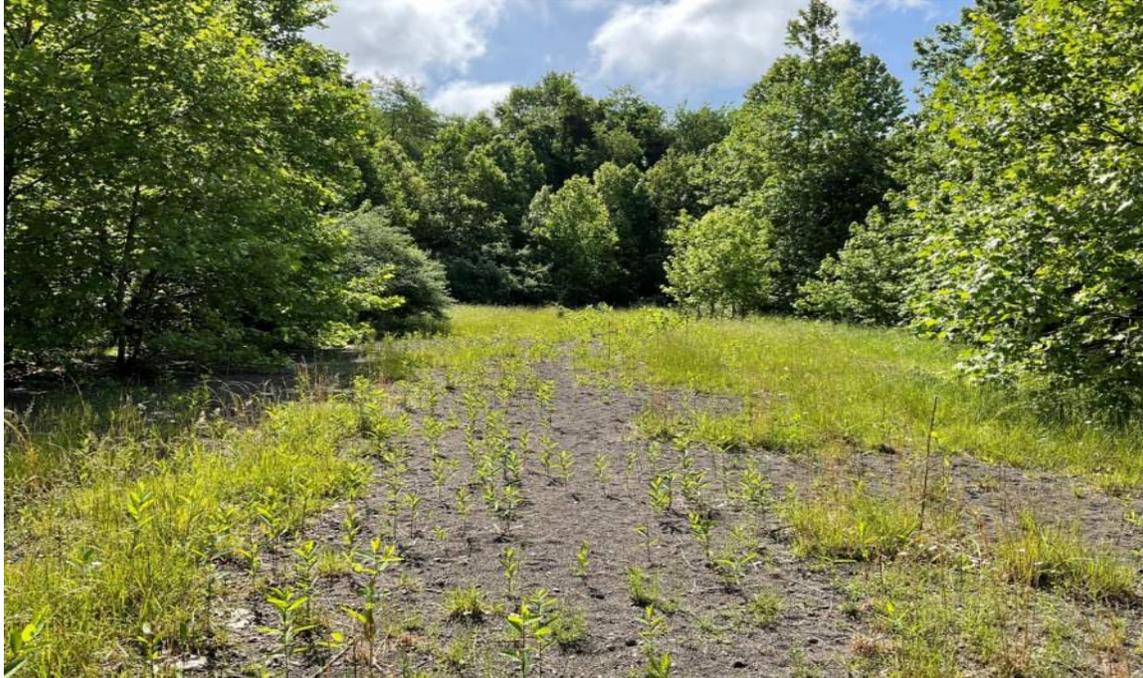
A large rectangular canopy gap that is approximately 0.75 acres in area exists just within the forested area to the southeast of the Yakoan park shelter and parking area. WPC staff noticed this unique site prior to fieldwork during their preliminary review of current and historical map images. They readily surmised that the site had been developed for some form of past human use due to its shape as a nearly symmetrical rectangle. Information regarding the history of this site was discussed during a meeting with staff from Harrison Hills Park and the Allegheny County Parks Foundation. The Harrison Hills Park Manager confirmed that this area was previously used as an outdoor event enclosure for equestrian showjumping.

Equestrian Canopy Gap at Harrison Hills Park

The WPC Forester recommends using two-gallon containerized plant material. Each tree could be individually tubed or caged, or the entire space could be fenced. Because the site is a neat rectangle, it could be less expensive to enclose this entire gap for deer protection versus a more rounded or irregularly shaped site. A suggested list of tree species is provided below.

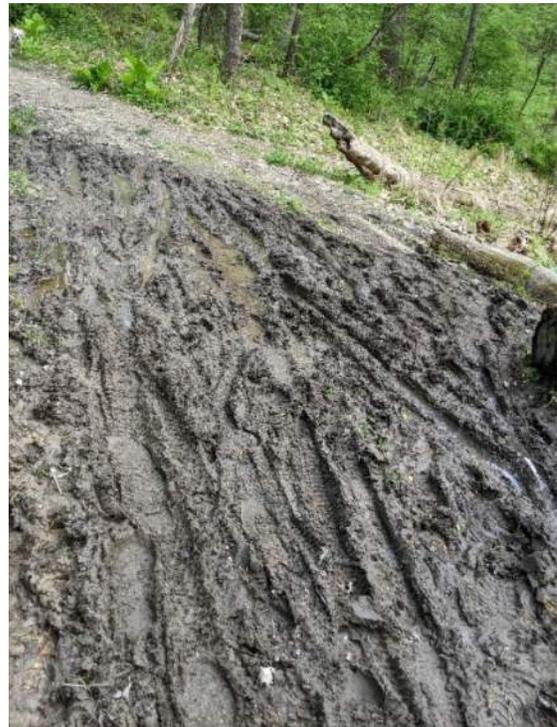
Trail Erosion on Green Trail

- Remediate trail damage at observed impact areas shown on the Map on **page 54**.
- The Lower Rachel Carson Run Ecological Integrity Area is a particularly important place to address trail issues, because off-trail traffic is impacting sensitive wildflower species (see southernmost trail impact point on **page 54**).

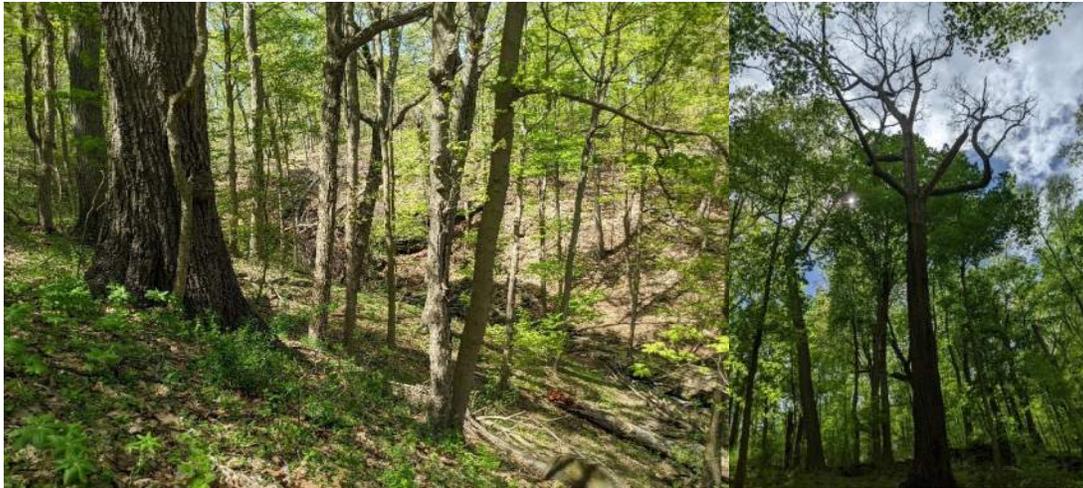
Several very large red oaks have recently died, creating canopy gaps. These gaps should be monitored for invasive species, to be removed if found, as the high-light conditions are very likely to attract invasive species. Restoration plantings may speed the recovery of a canopy and ensure that it is composed of native species. A small landslide area is noted on the map (**page 59**) and could also benefit from canopy-gap restoration techniques. Deer browse protection, either deployed locally around canopy gaps or in the form of a larger fence protecting the entire ravine, will greatly facilitate regeneration and protect restoration plantings.

Lower Rachel Carson Ravine & Dead Red Oak creating a Light Gap.

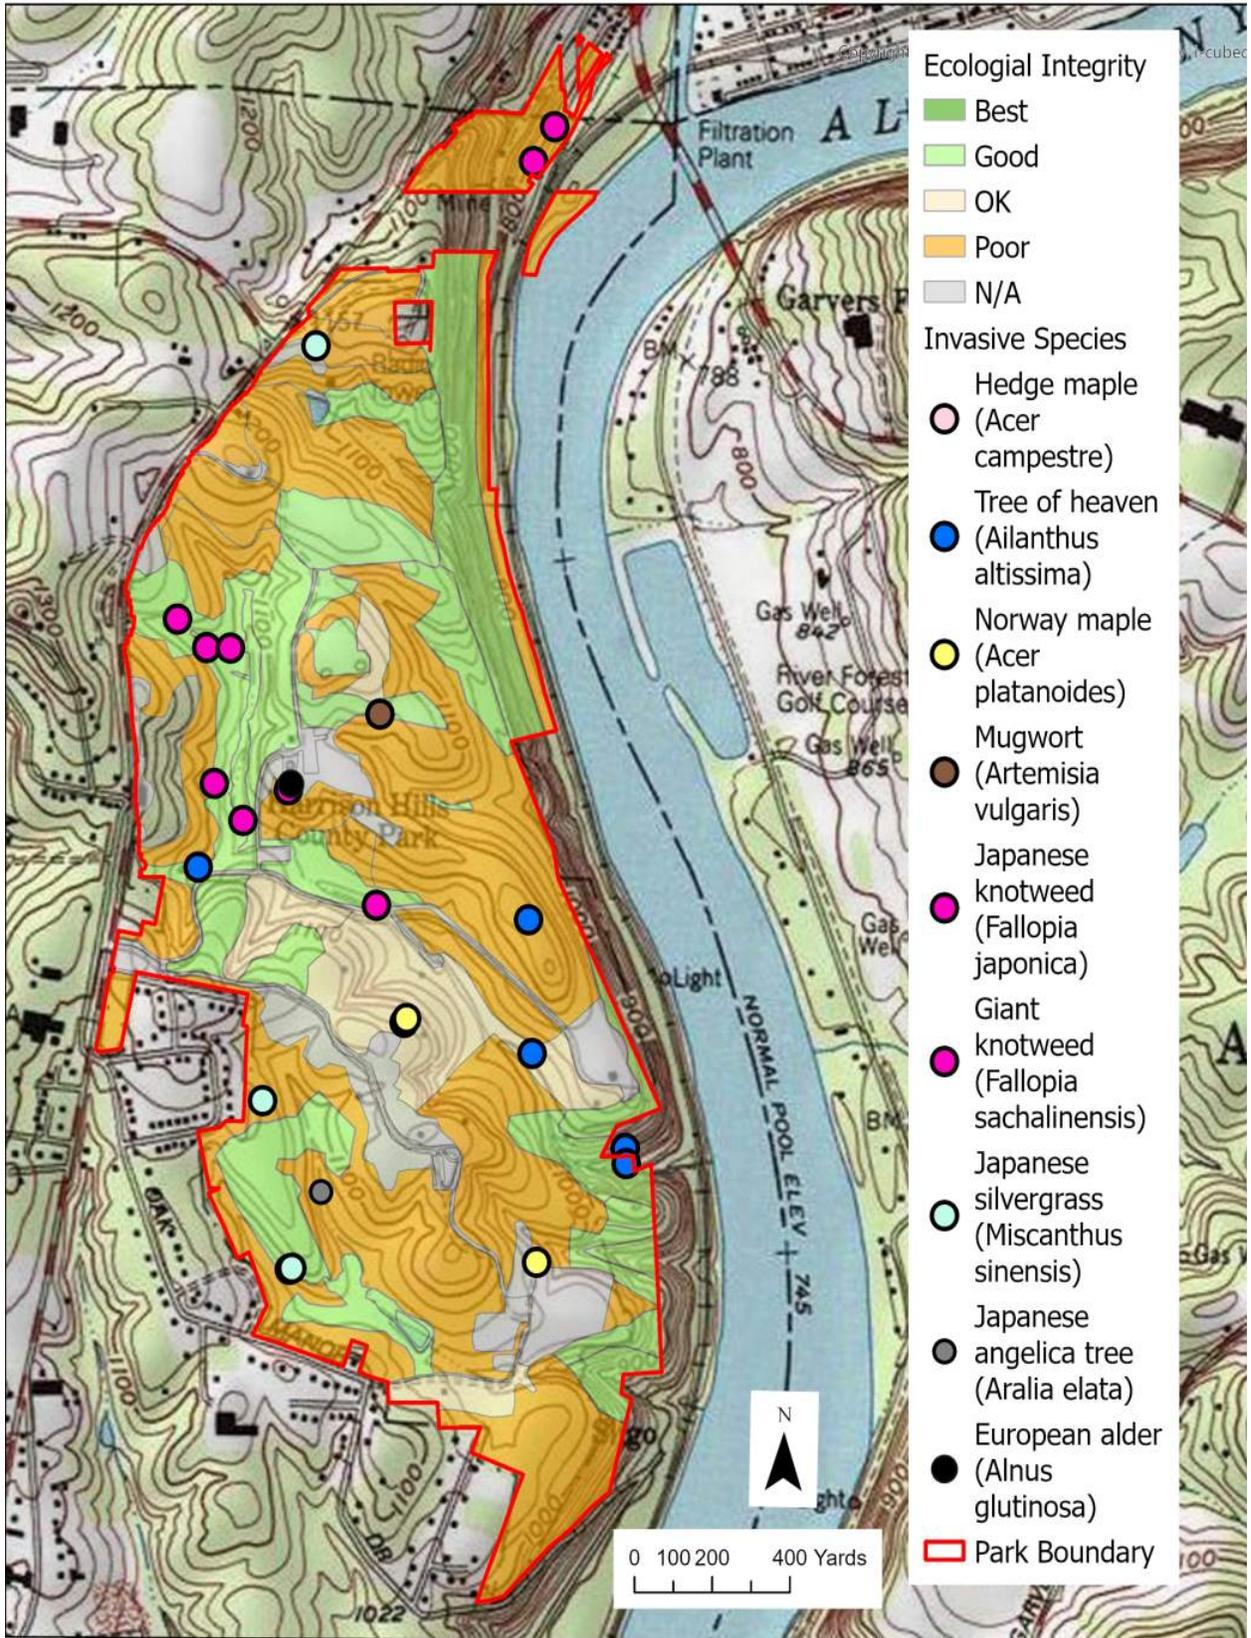
Japanese Knotweed and Giant Knotweed removal in Upper Rachel Carson Run “Good” Ecological Integrity Area

- Control the Japanese knotweed patches that have established in this area. This species will form a dense monoculture, displacing all other native species and greatly reducing the habitat value for native birds, amphibians, and even white-tailed deer. See project recommendations section for more detail on potential control methods.
- Control of other invasive species will also be beneficial to the long-term viability of the native ecosystem.
 - Remove invasive shrubs (Japanese barberry, introduced honeysuckles, privet, multiflora rose).
 - Monitor wetland herbaceous invasive species (reed canarygrass, Japanese stiltgrass, introduced Iris) and if they are expanding, pursue wetland-safe treatments.

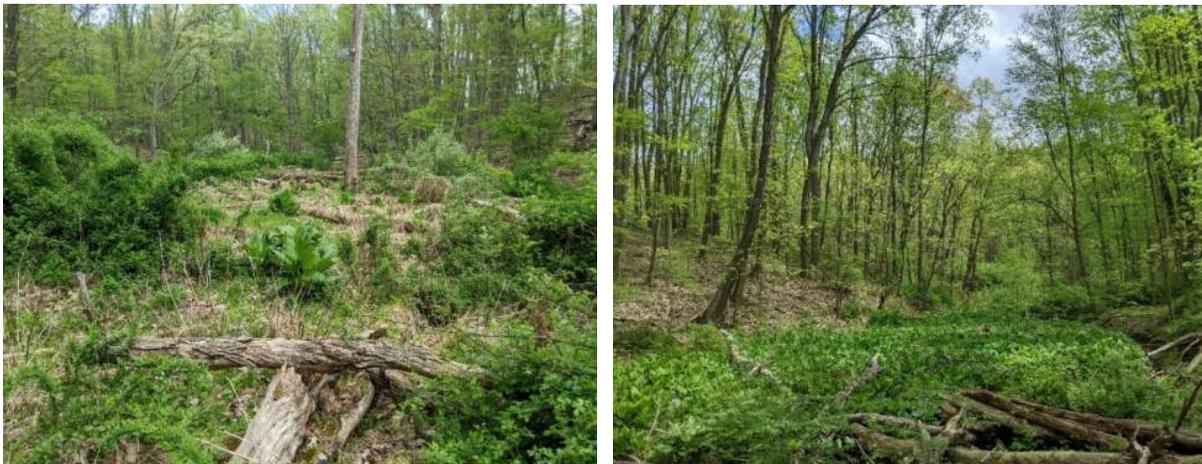
Wetlands in Upper Rachel Carson Run with Autumn Olive & Other Invasive Species

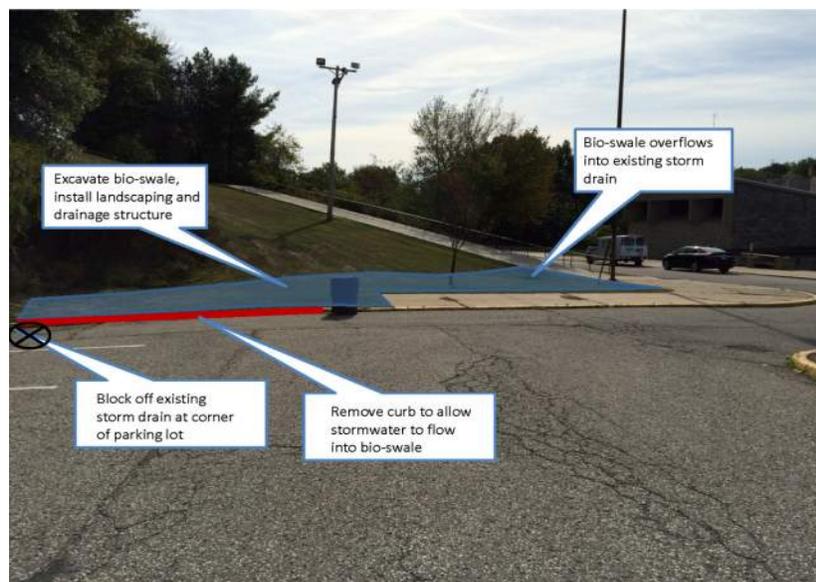
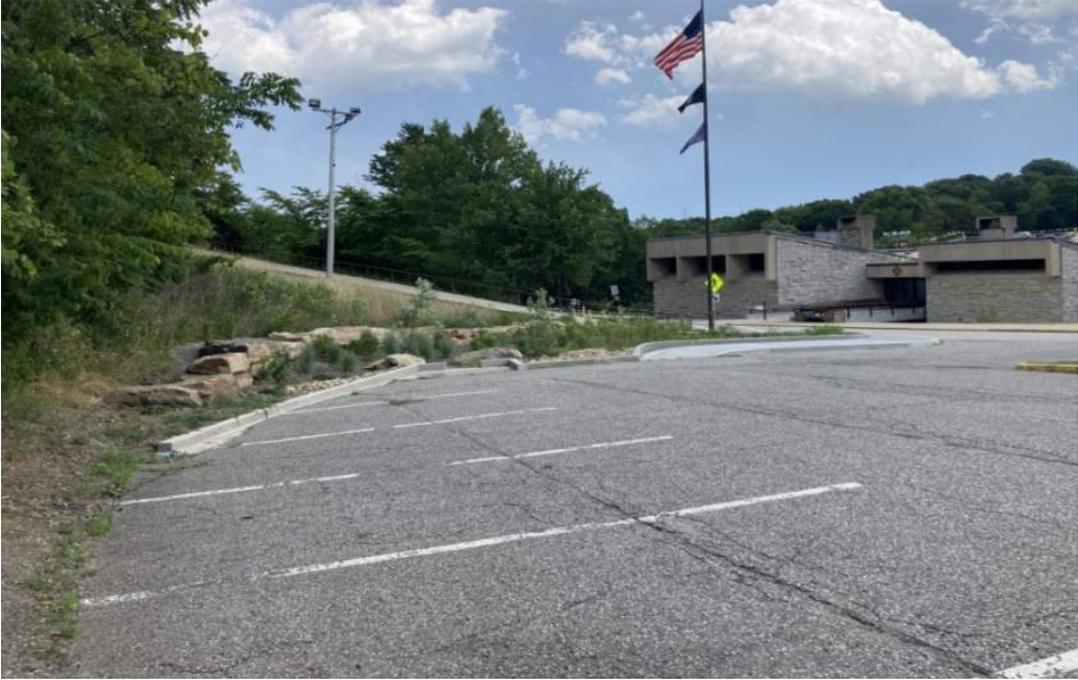
Constructed Boyce Park Ski Lodge Bioswale (2022)

Located at the bottom of a large parking area at the Ski Lodge, this bioswale receives runoff via a section of removed curb (or “curb cut”). Rocks, plants, and mulch slow down the rush of runoff, promote infiltration of the runoff into the ground, and remove pollutants. Previously the runoff was conveyed via storm sewers directly into a tributary of the Pierson Run stream.

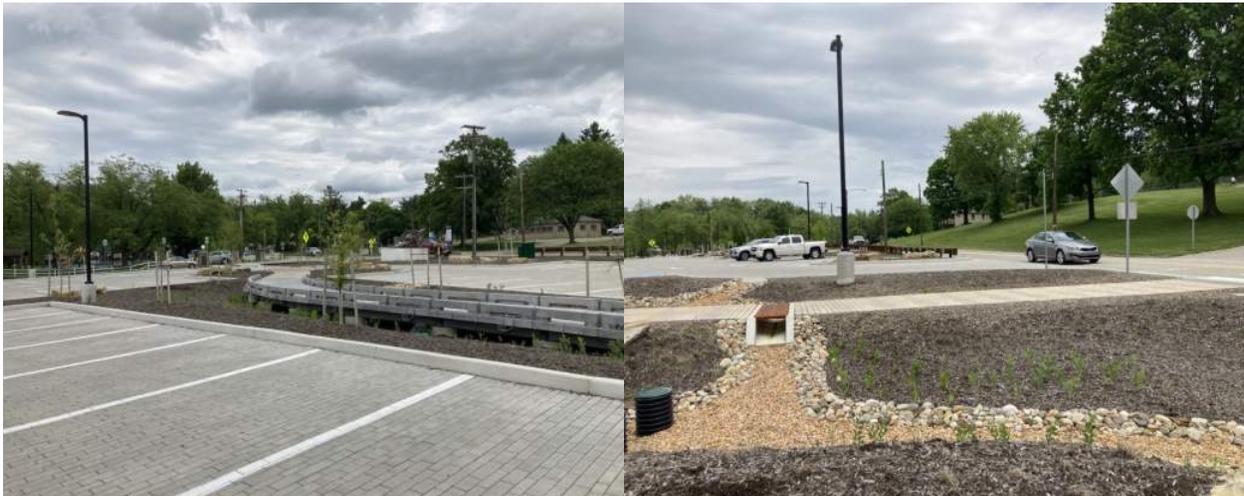
Permeable paving, bioswales and trees installed at the South Park green design parking solution (2021).

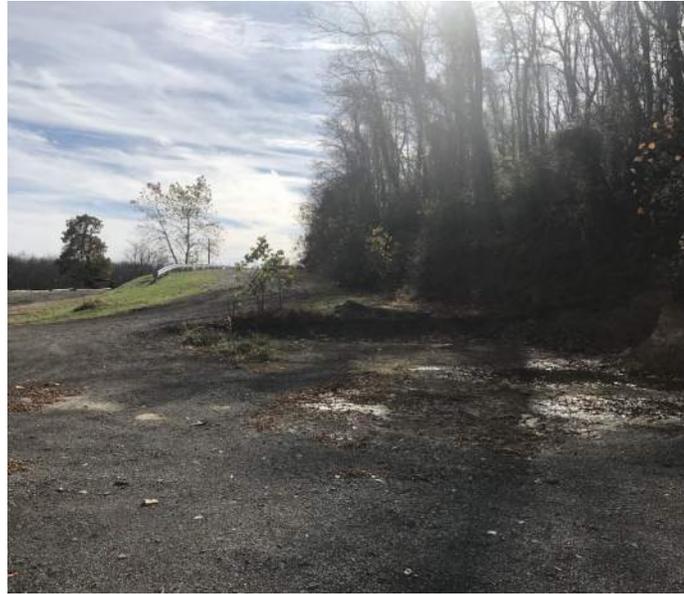
Ponding & Erosion in the Soccer Fields parking lot.

A bioswale facility that includes rock for slowing the runoff and plants, trees, and mulch to promote infiltration would significantly reduce the erosion and ponding and beautify the site. The parking lot currently feels unwelcoming, isolated, and in need of maintenance. Piles of asphalt millings at the northern end of the lot are unsightly and contribute to stormwater management problems. Constructing a bioswale and adding other amenities such as trail wayfinding, informational signage, lighting, and paving improvements would significantly improve the function and appearance of this high-use area of the park.

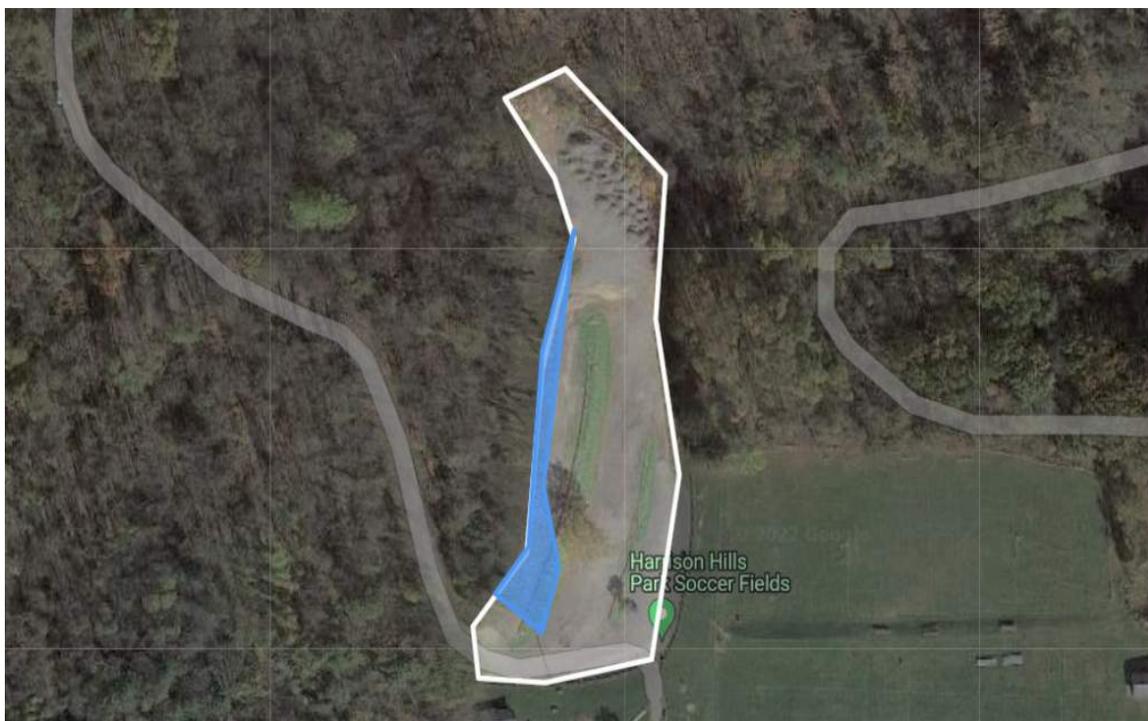
The Soccer Field parking lot bioswale would intercept 94% of a 24 hour 1” storm (remaining 6% would evapotranspire).

Proposed location of Harrison Hills Park Soccer Field Bioswale
